## PROPERTY INSPECTION REPORT

**Concerning:** Property Address **Insp.#: 191127 - A** **Agent:**  
(Address or Other Identification of Inspected Property)

**By:** Danny Pitts, TREC License # 4717 **11/27/19**  
(Name and License Number of Inspector) (Date)

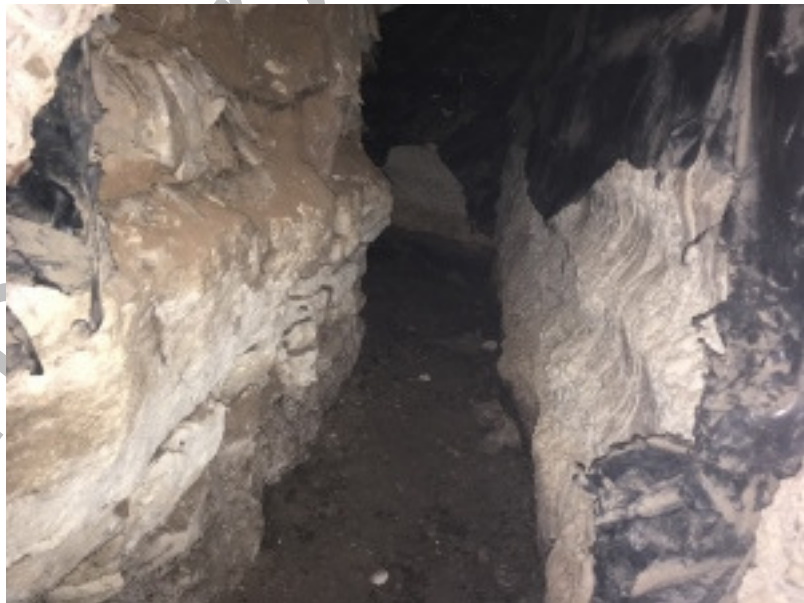
- THE PIER & BEAM FOUNDATION – The pier & beam foundation was generally found to be in satisfactory condition on the day of the inspection
- THE CRAWL SPACE - Was inaccessible at the right rear (the kitchen area) due to the low clearance & in front of the “tunnel” under the den because it narrowed to become impassible.

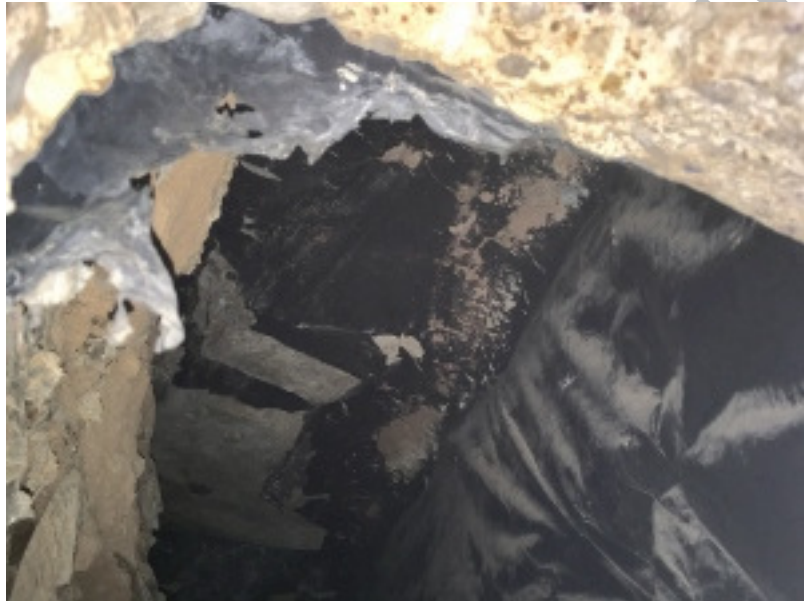
- BELOW IS A PICTURE OF THE BOTTOM OF THE SLAB FLOOR JUST INSIDE THE TUNNEL.

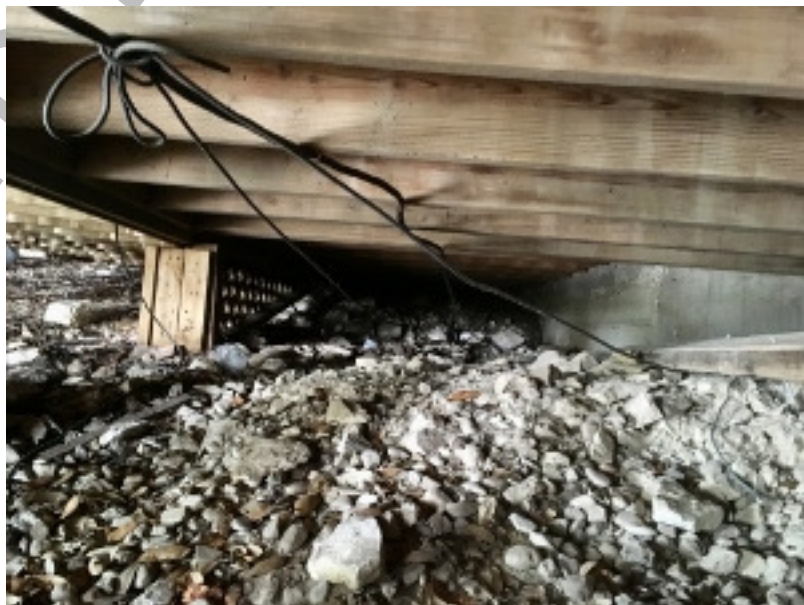
- THE PIER & BEAM FOUNDATION PIERS – Are poured concrete, depth of the footings is unknown.
- ALL WOOD BEAMS & FLOOR JOISTS THAT ARE WITHIN 12 IN. OF THE GROUND – Are not pressure treated wood as required at the right under the kitchen.

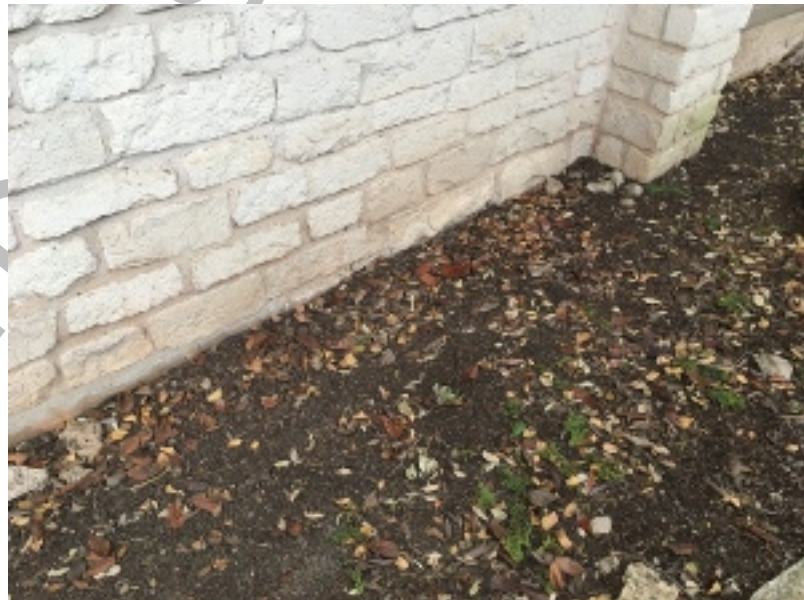
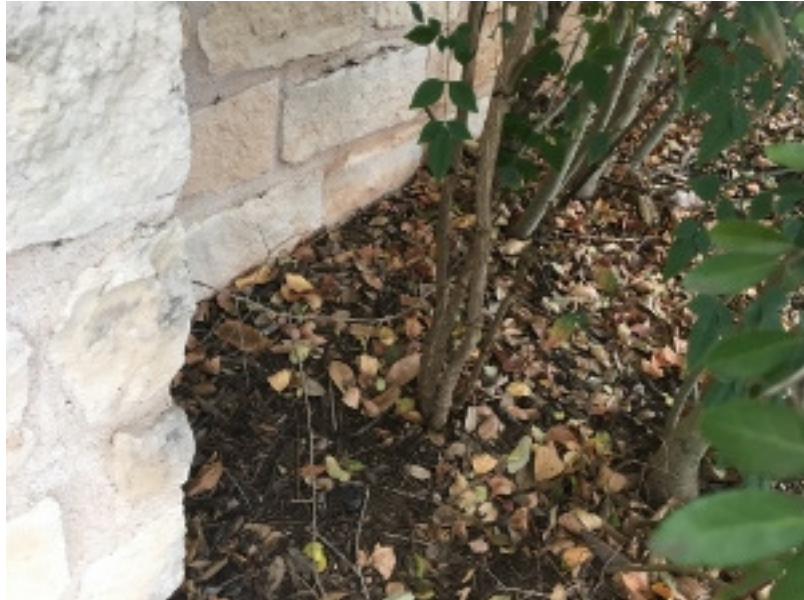
- REGRADE THE SOIL – To expose 4 to 6 in. of the slab at the right rear & the left front of the living room.

- Regrade the soil down & away from the foundation (the code requires 5% slope extending 10 ft. out from the house) to divert the water around & away from the house, especially at the right rear. In other words, this means that the soil should fall 6 in. within 10 ft. of the house on all 4 sides of the house.

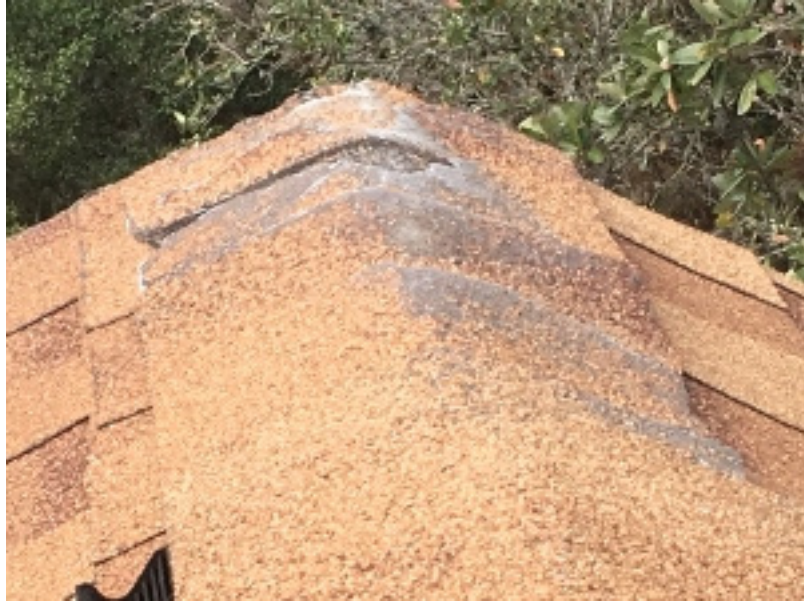
- THERE ARE TREE DAMAGED SHINGLES – At the rear of the ridge at the left rear gable roof.

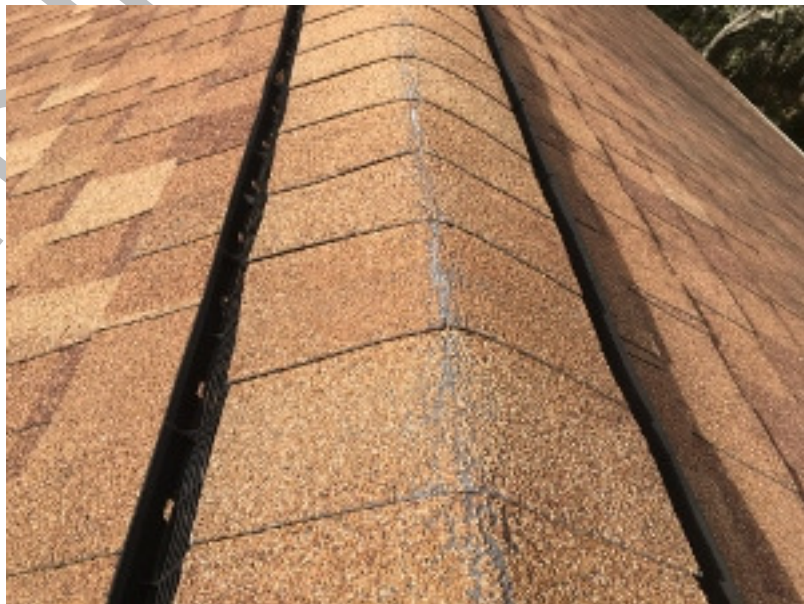
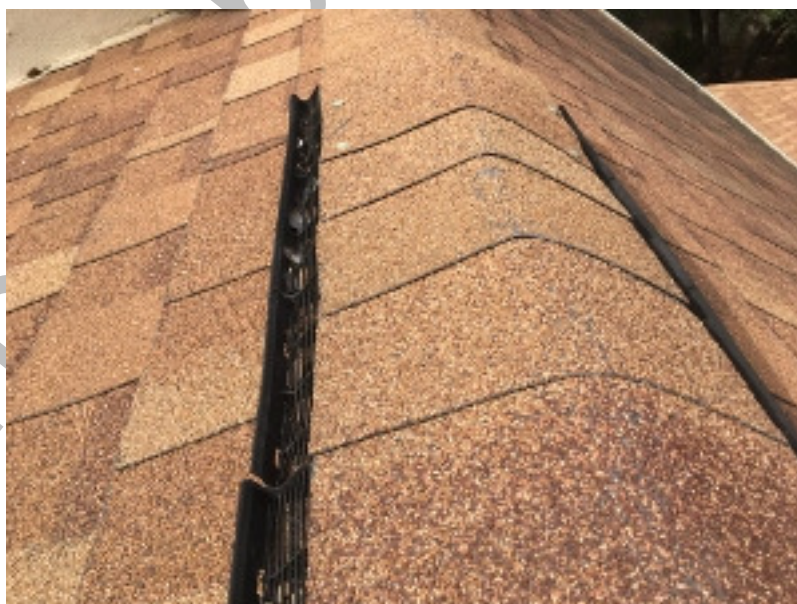
- THERE ARE MULTIPLE DAMAGED / WORN RIDGE CAP SHINGLES – At various locations.

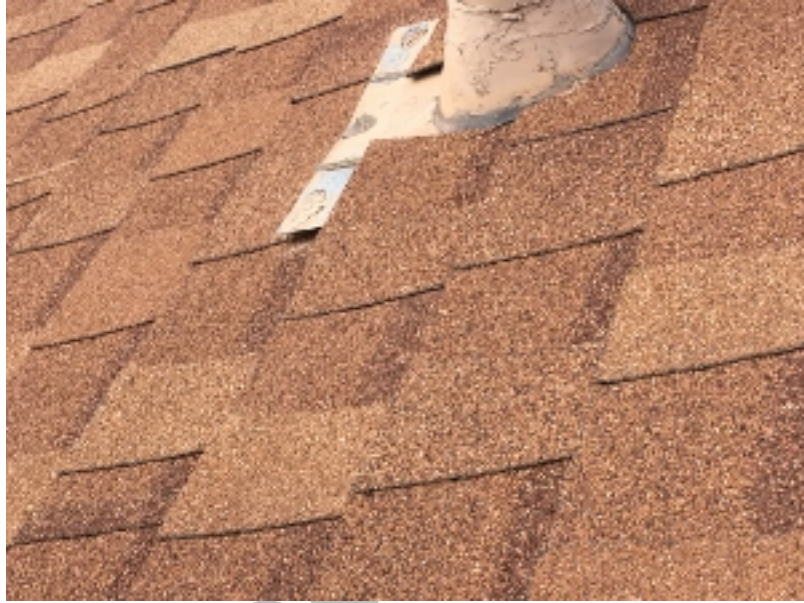
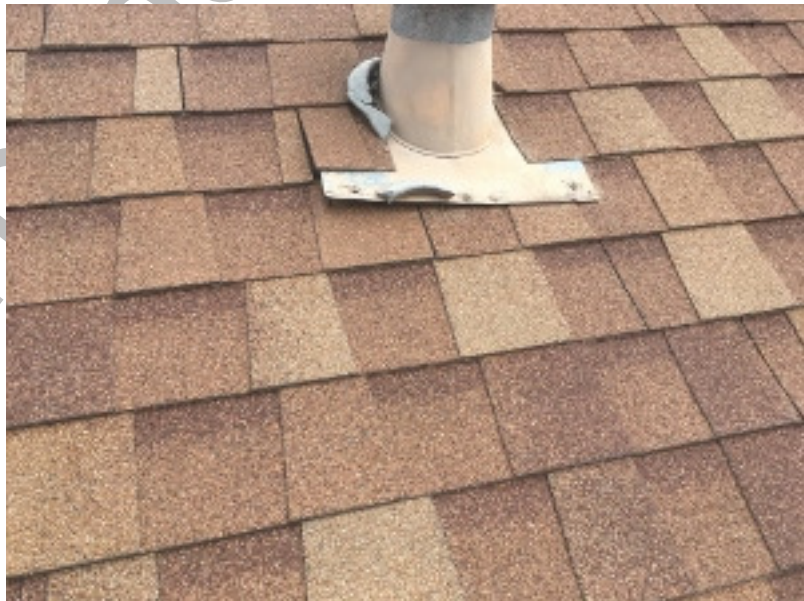
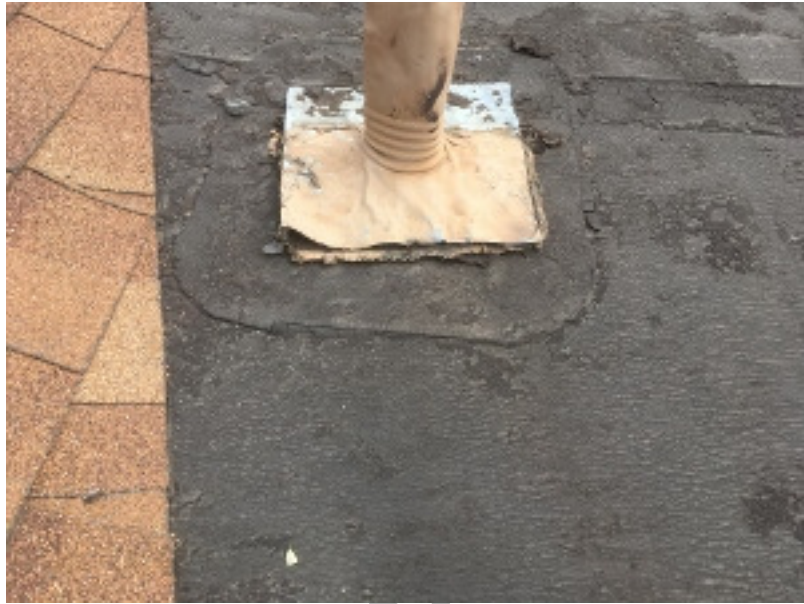
- THE PLUMBING & MECHANICAL VENT PIPE FLASHING BOOTS - Are loose at various locations, renaill.

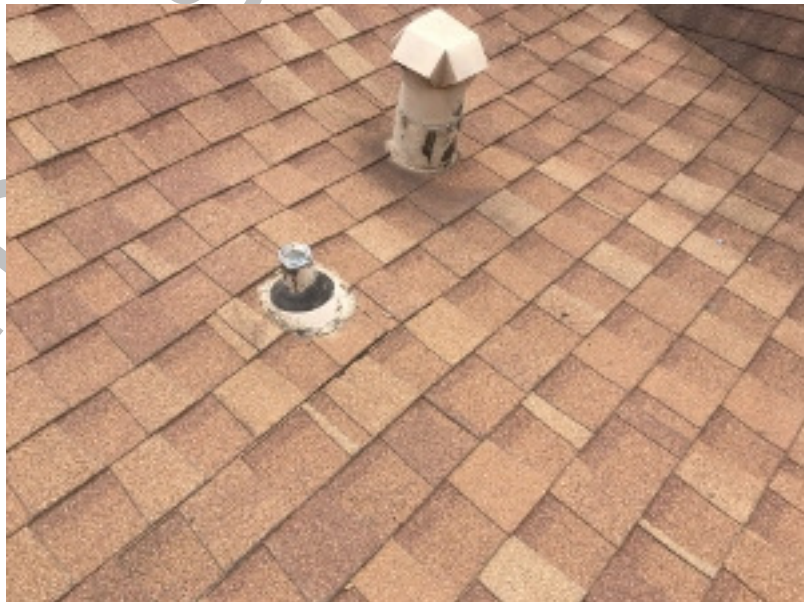
- The boots are not properly installed (the bottoms of the boots are not on top of the shingles) at the rear of the garage.

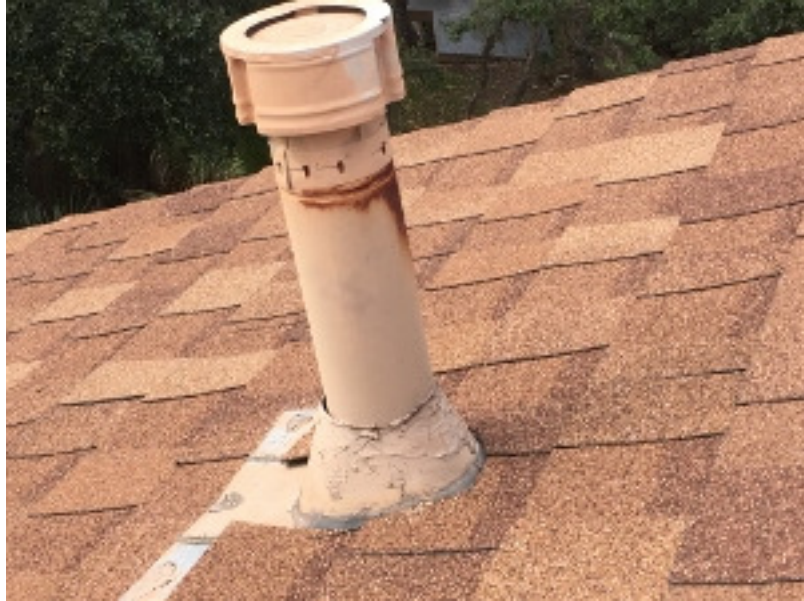
- A RAIN COLLAR TO PREVENT WATER LEAKAGE INTO THE ATTIC – Is missing at the upstairs rear water heater vent pipe.

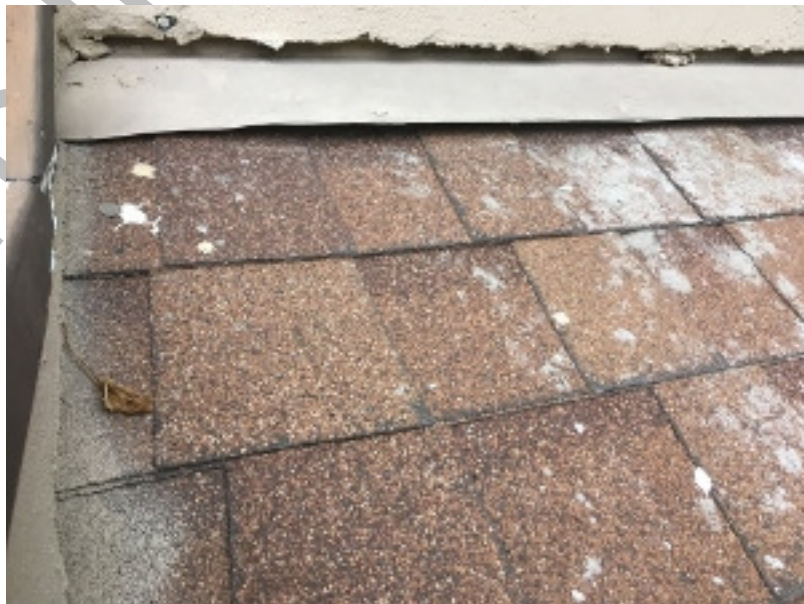
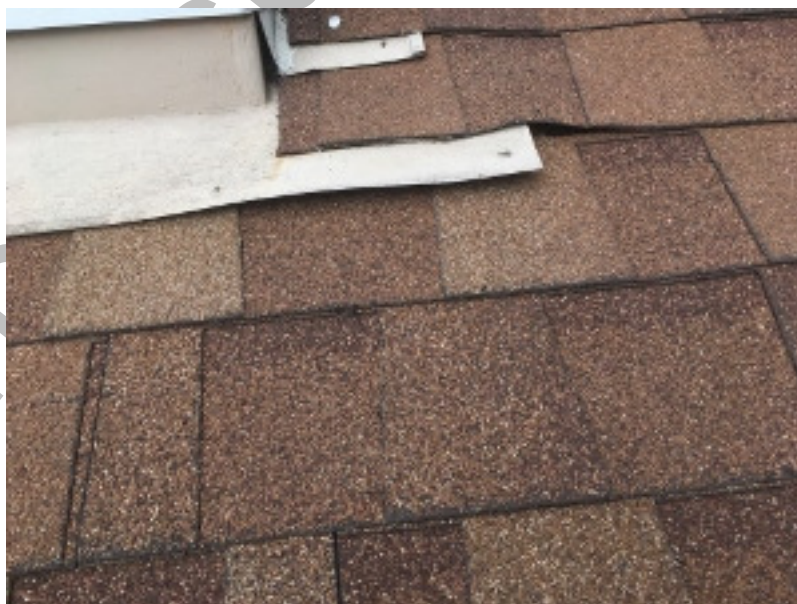
- THERE ARE LOOSE / RUSTED FLASHINGS – At various locations including at the skylight, the left rear & the chimney.

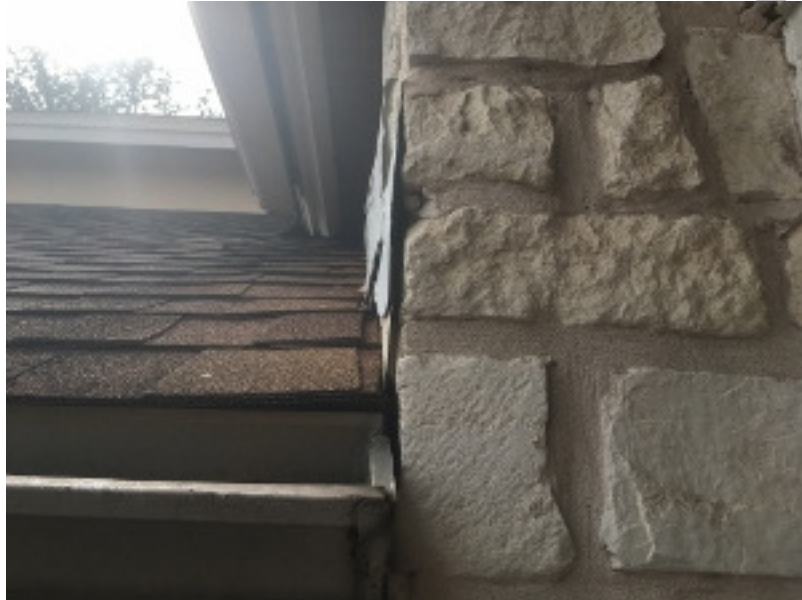
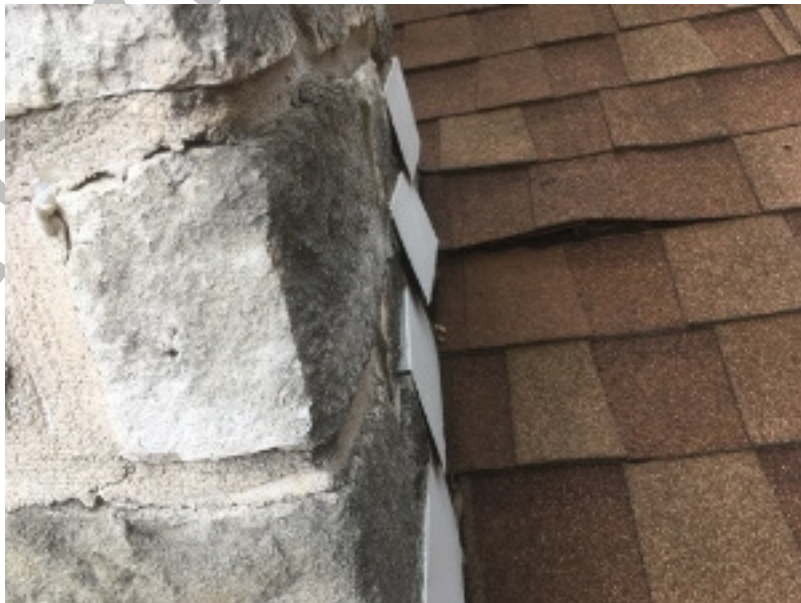
- SEAL THE COUNTER FLASHINGS / FLASHING ENDS – At the roof / wall connections at various locations including at the left of the garage to prevent water penetration.

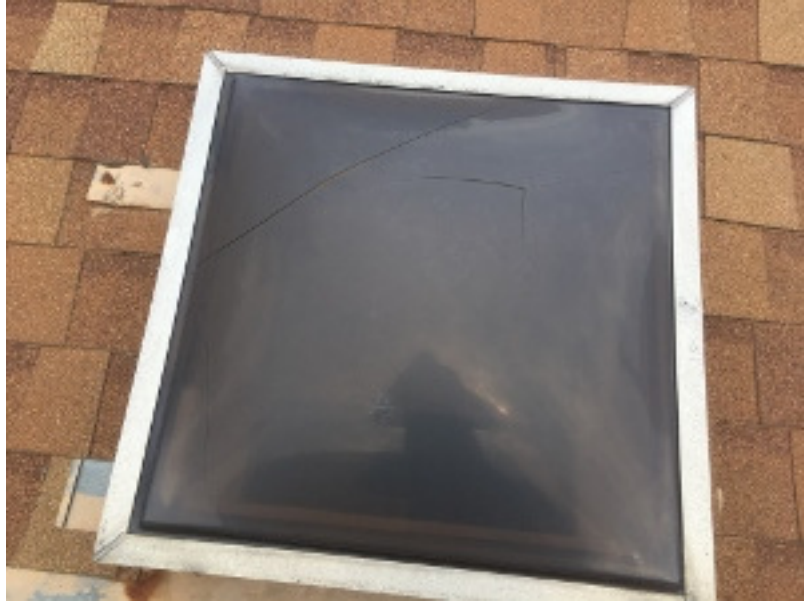
- THE SKYLIGHT – Is broken at the game room.

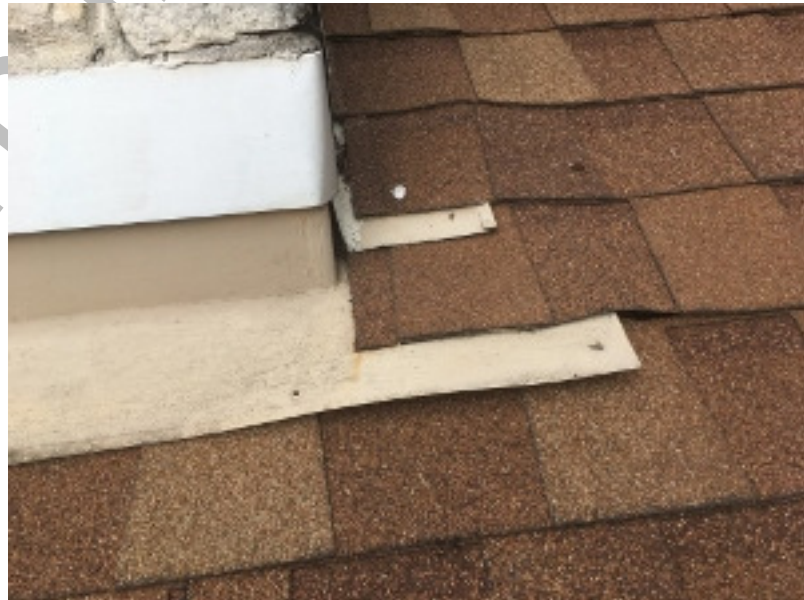
- THERE ARE MISSING STEP FLASHINGS – Step flashings are required at the roof / wall connections by code. NOTE: Turnback flashings / J flashings are present rather than step flashings. The use of turnback flashings is a common construction practice in the Central Texas region.

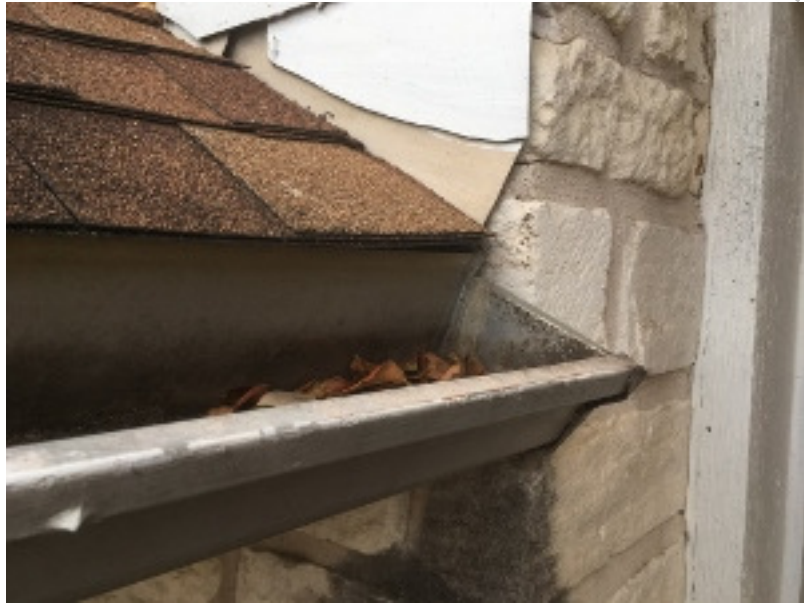
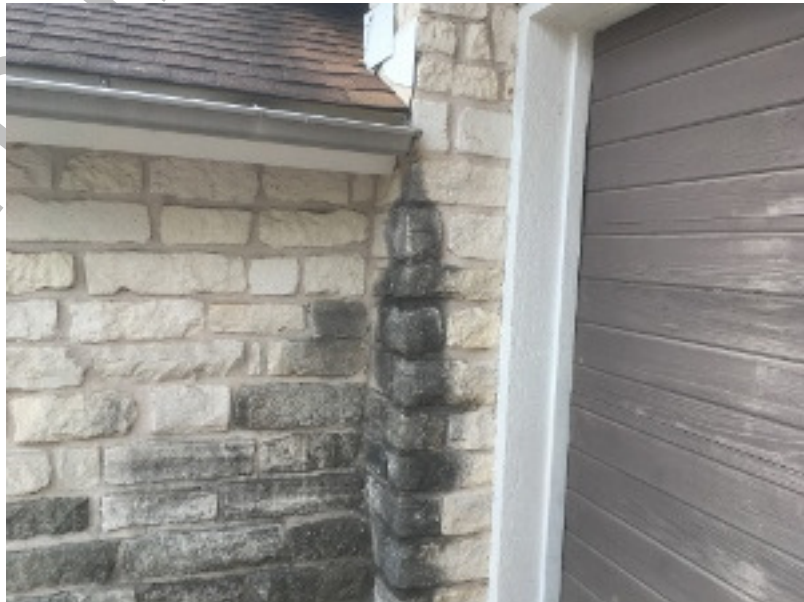
- THERE ARE MISSING FACTORY BUILT KICKOUT FLASHINGS – At the roof / wall connections at various locations including at the left of the garage & the right rear where a wall extends below the roof termination (to prevent water penetration behind / into the siding).

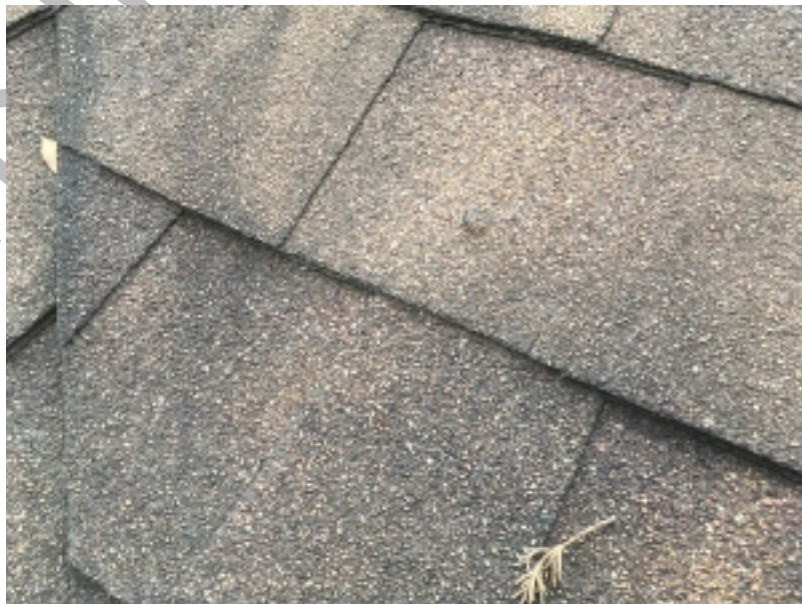
- THERE IS AN EXPOSED ROOF NAIL – Through the surface of the shingles at the rear of the valley above the garage.

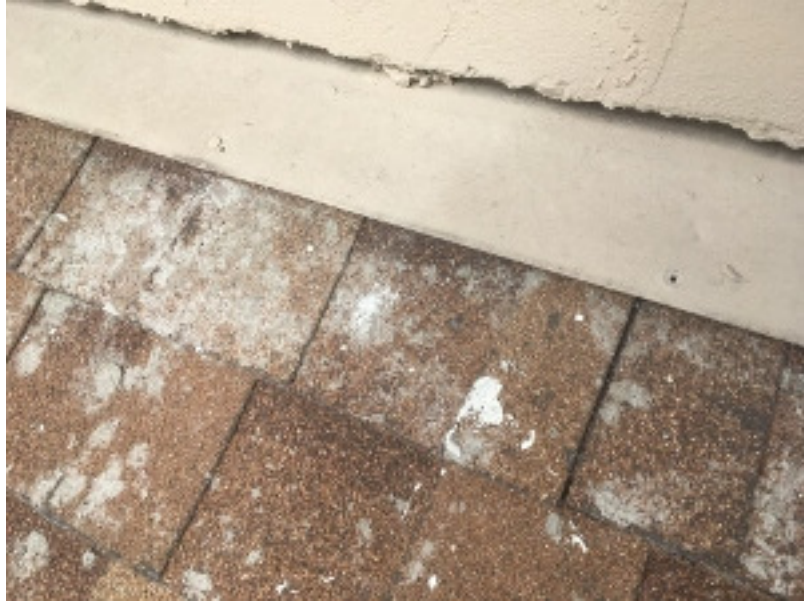
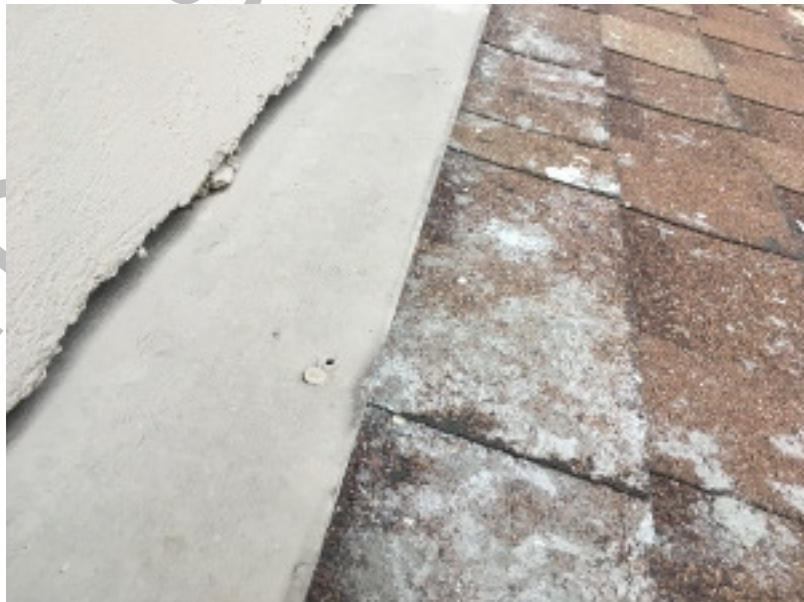
- THERE ARE MISSING NAILS LEAVING HOLES – At the roof / wall flashing at the rear of the chimney / front of the master suite deck.

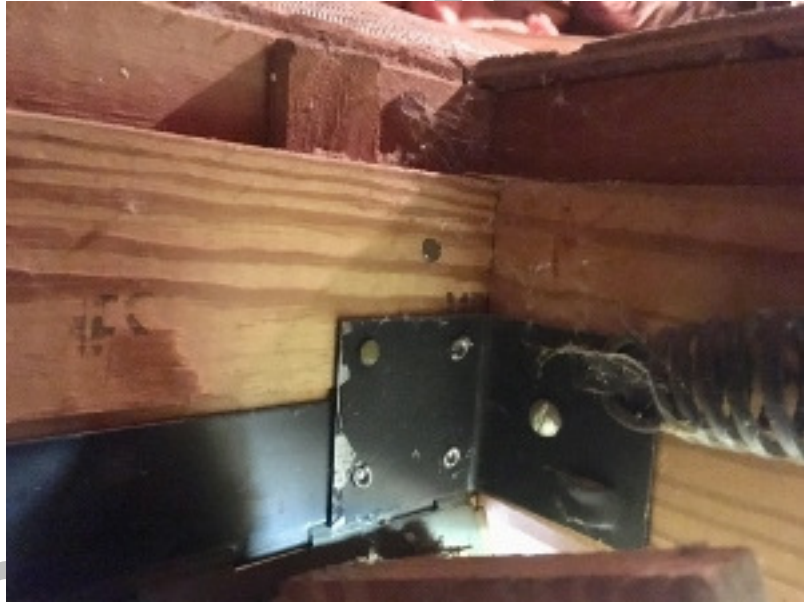
- Joist hangers are missing at the headers between the ceiling joists at the attic door.

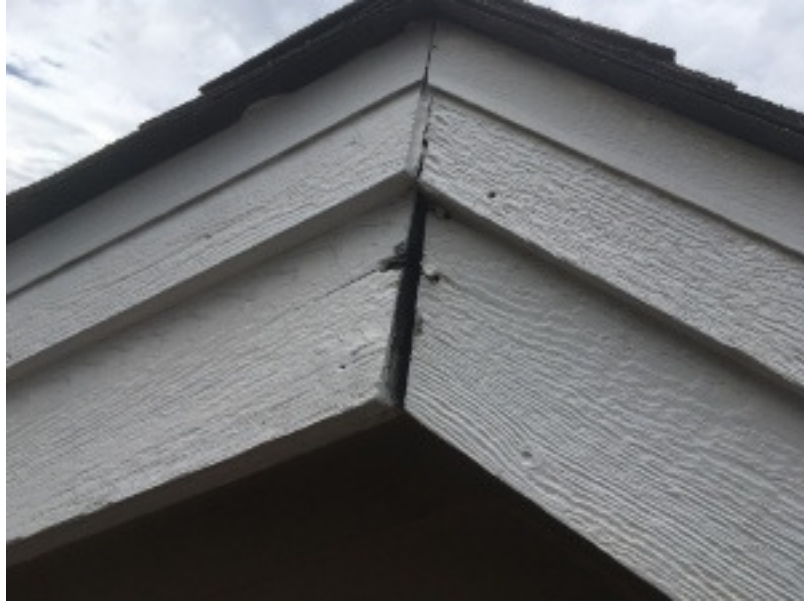
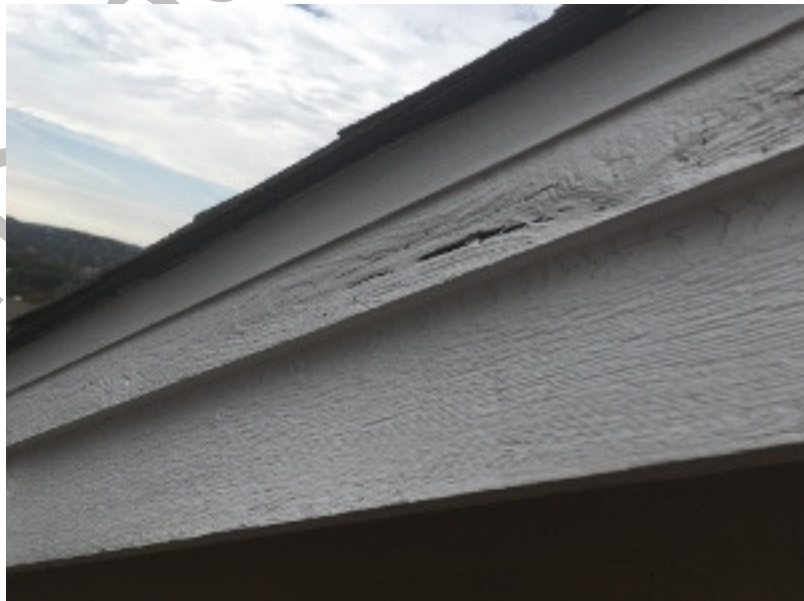
- DECAYED / DAMAGED FASCIA & DRIP MOLD – At various locations including at the right of the chimney.

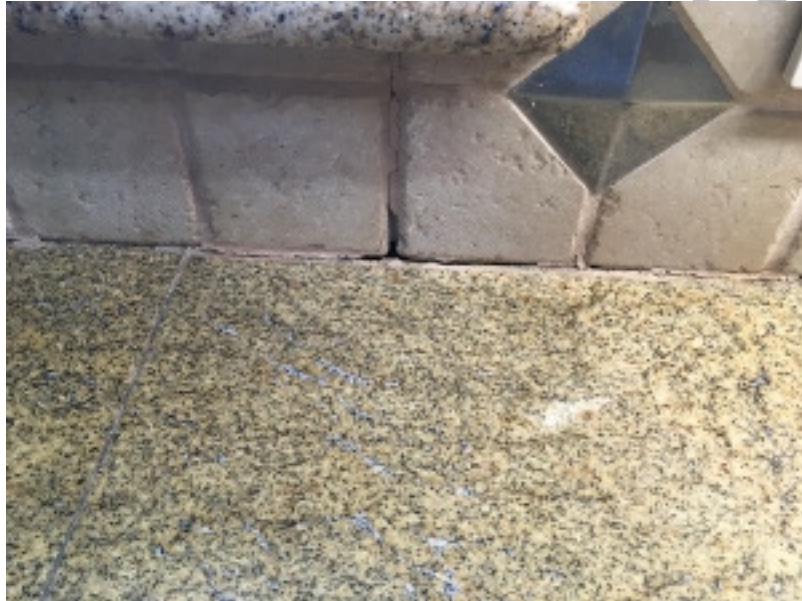
- THE KITCHEN COUNTERTOP – Recaulk the tile backsplash to the countertop.

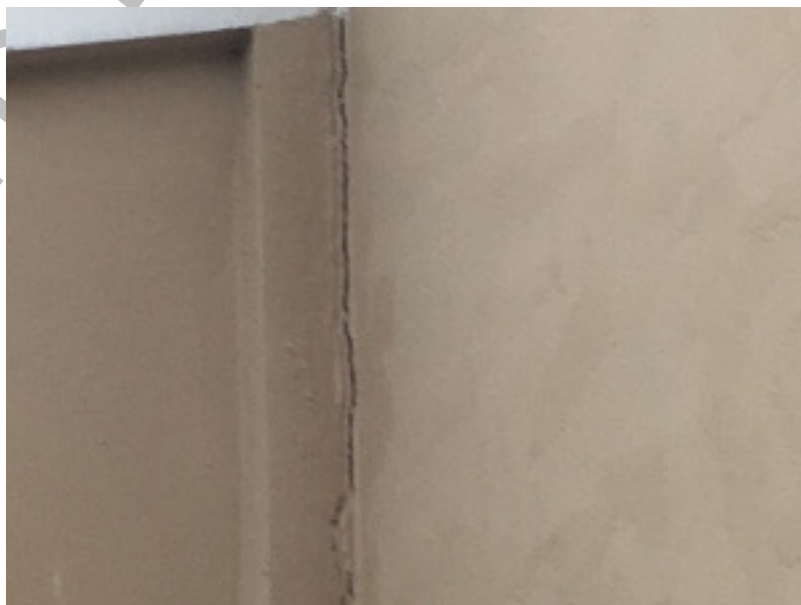
- THERE IS SHEETROCK CRACKING – At the downstairs fireplace.
- STUCCO SIDING IS PRESENT – This report does not attempt to identify the type of stucco system installed or the installation methods used to install this stucco system. I am not an expert in the evaluation of stucco siding. If concerned, have a certified stucco specialist advise you.
- THERE ARE CRACKS IN THE STUCCO – At various locations including at the left rear.

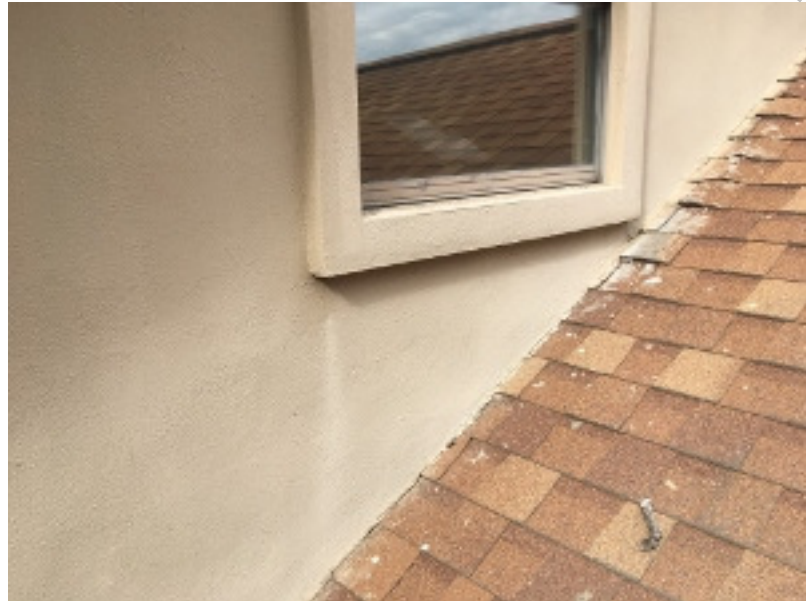
- THERE IS DAMAGED STUCCO – At various locations including at the left deck pillars.
- PROPERLY INSTALLED STUCCO CONTROL JOINTS / EXPANSION JOINTS – Are missing. Joints are not present for every 144 square feet of wall area (a rough industry standard), at the second story floor line & at all the corners of the door & window openings.

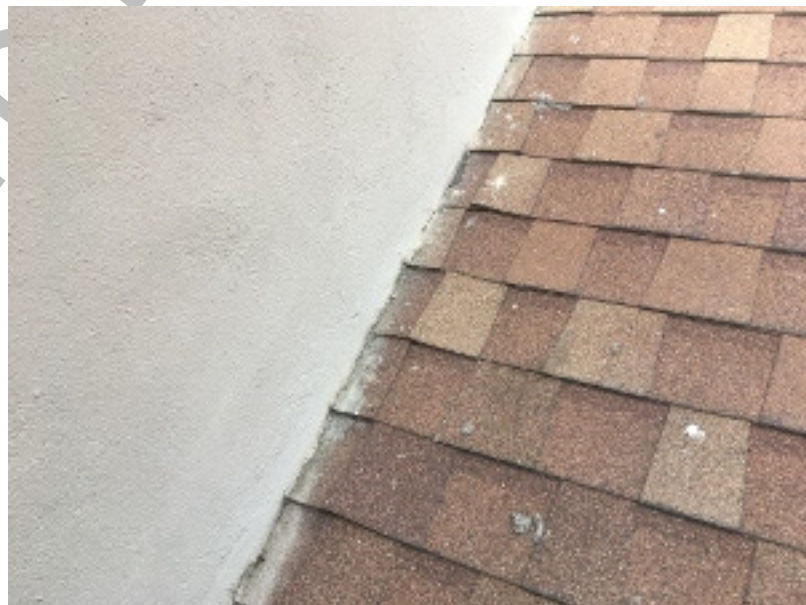
- WEEP SCREED FLASHING TO PROVIDE A DRAINAGE PLANE FOR THE STUCCO – Is missing at the bottom of the walls.
- THE STUCCO SIDING AT THE ROOF / WALL CONNECTIONS – Does not have 2 inch clearance from the shingles at various locations.

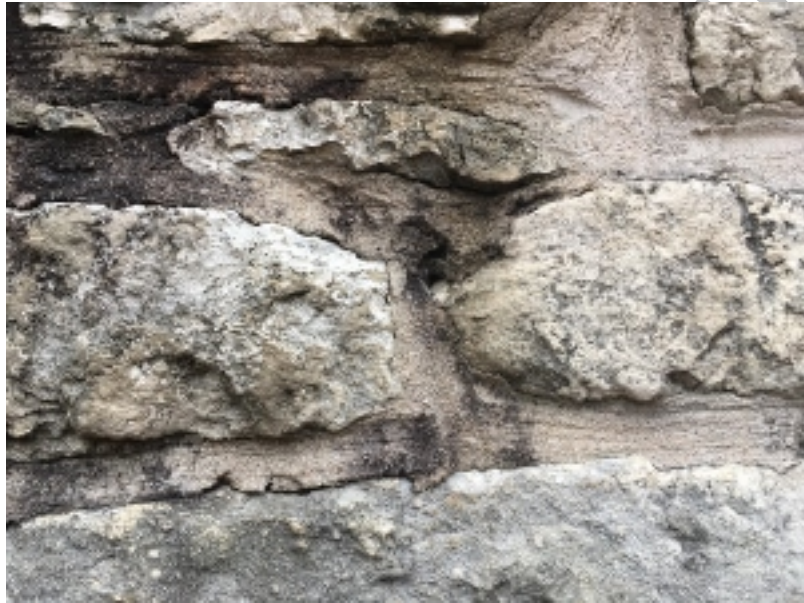
- THERE ARE CRACKS / HOLES IN THE ROCK MORTAR - At various locations. Seal the cracks & holes to prevent water penetration.

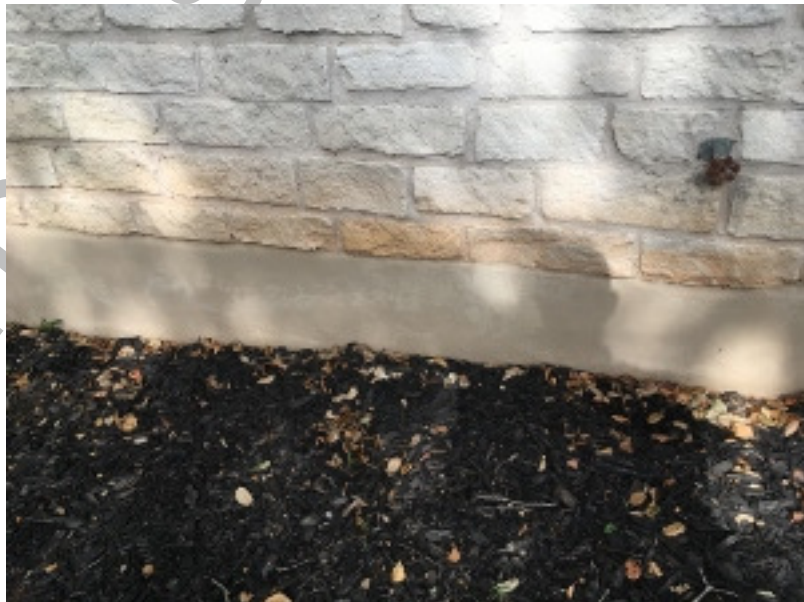
- WEEP HOLES EVERY 33 IN. – Are missing at the first layer of the rock & above the door & windows at various locations.

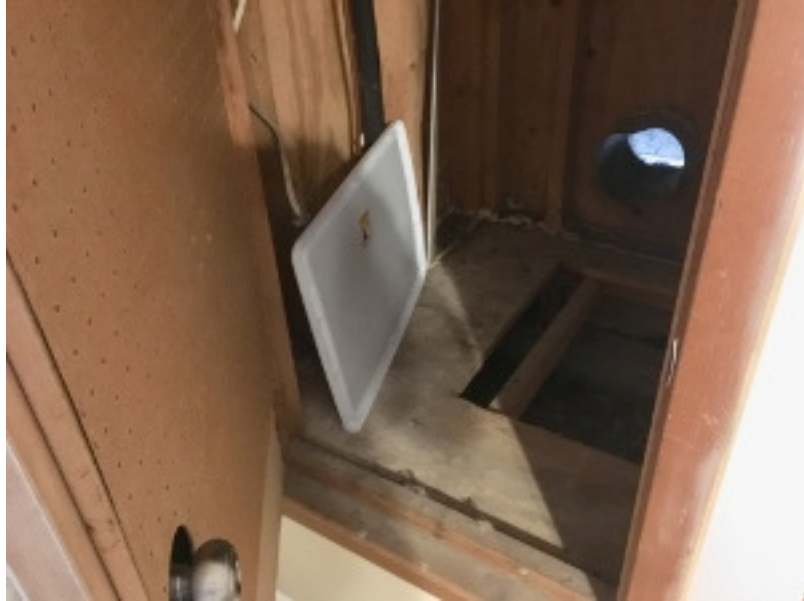
- THE DOOR FOR THE ABANDONED AC CLOSET IN THE GAME ROOM – Is not a solid core door.
- THE WEATHER STRIPPING IS MISSING – At the abandoned AC closet door.
- THE DOOR SWEEP - Is missing at the abandoned AC closet door.

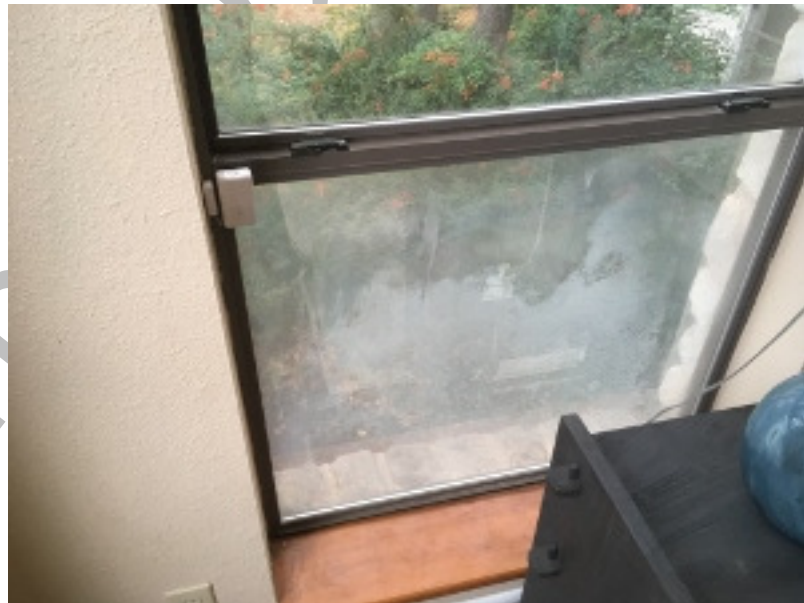
- THERE ARE FOGGED WINDOWS - At the left in the living room & the master bath.

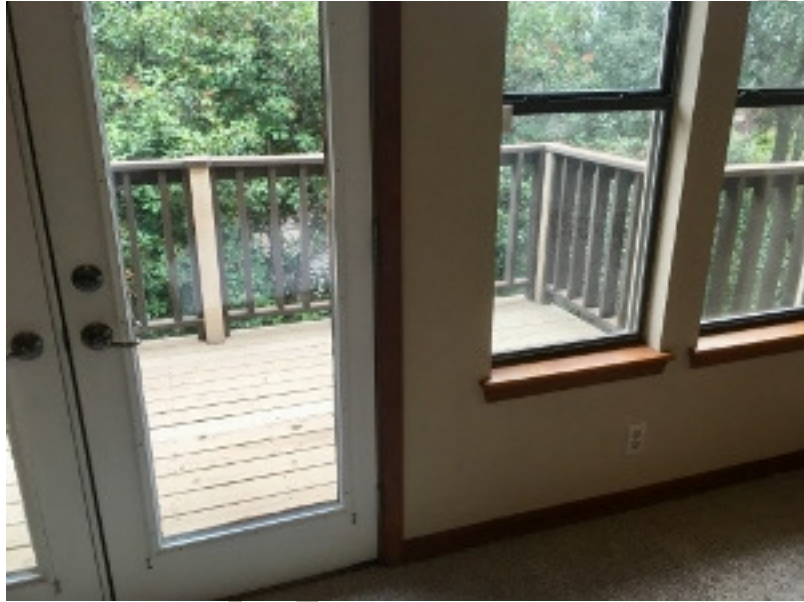
- THERE ARE MISSING SCREENS – At all the windows (there are screens in the garage).
- ALL WINDOWS WITHIN 2 FT. OF A DOOR - Must be safety glass. The window is not designated as tempered glass adjacent to the master bedroom door.

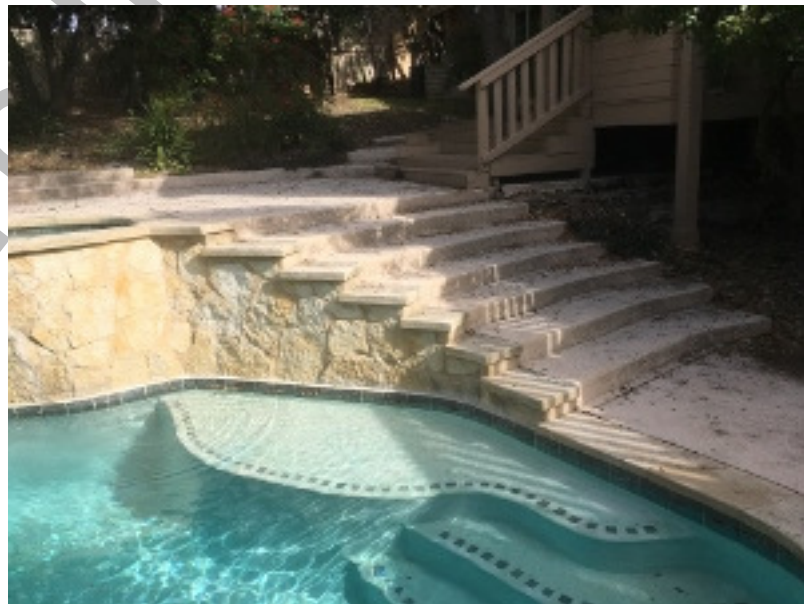
- THE STAIR RAILING IS MISSING – At the pool stairs. When 3 or more steps are present (a railing is required & pickets must be 4 in. apart maximum).

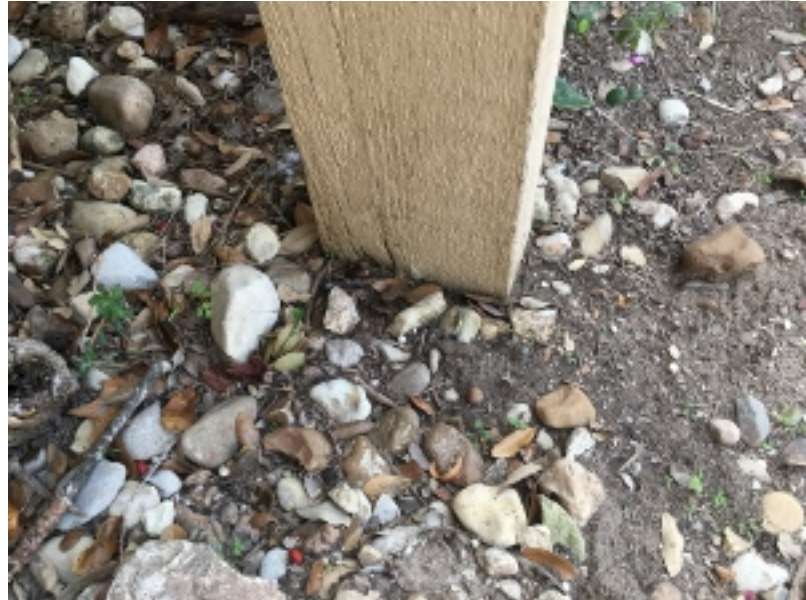
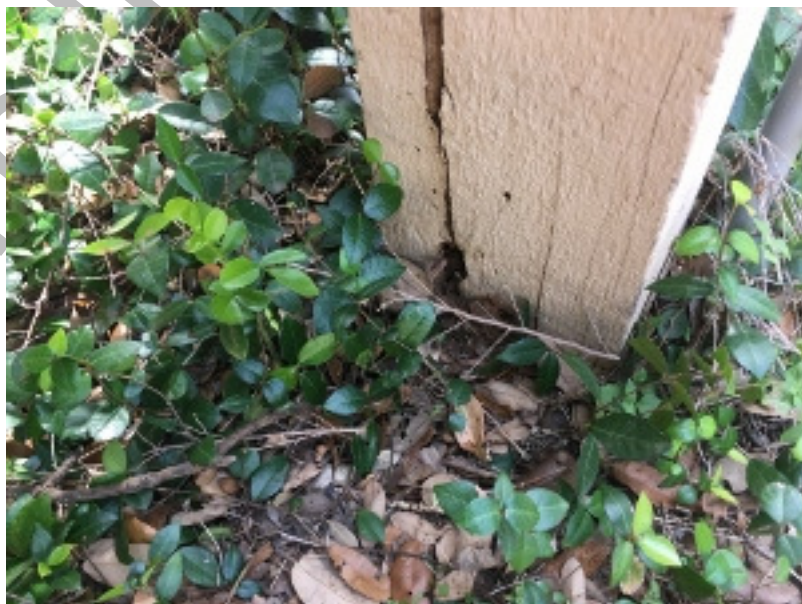
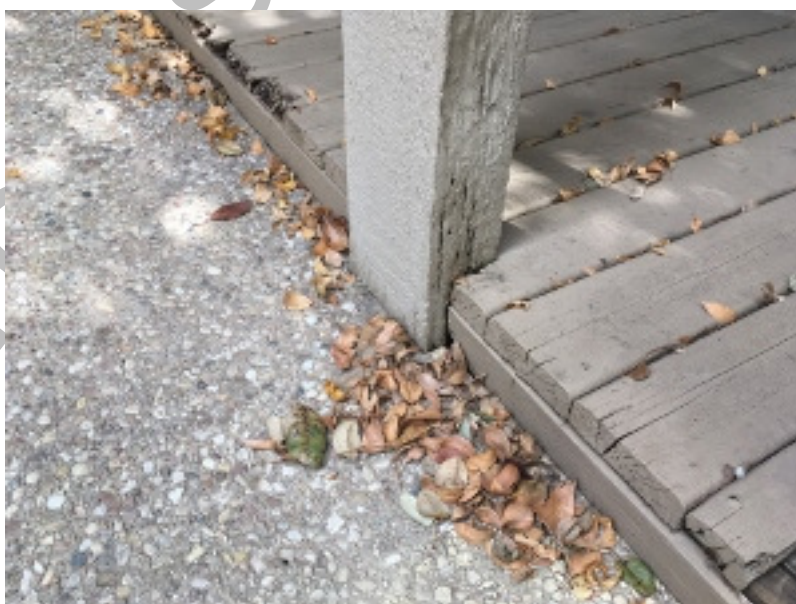
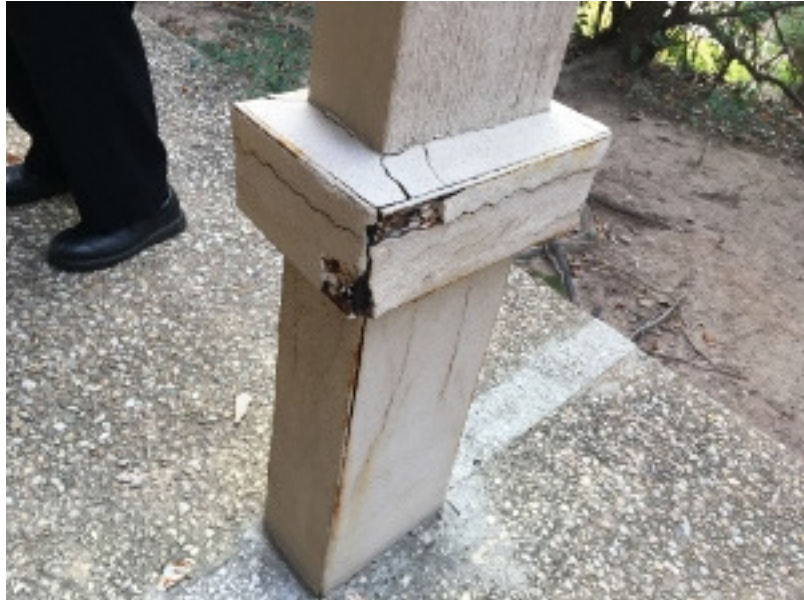
- THE REAR DECK POSTS - Have wood to soil / concrete contact, add post holders at the left. The bottoms of the posts are damaged / decayed at various locations. The posts should be repaired / replaced.

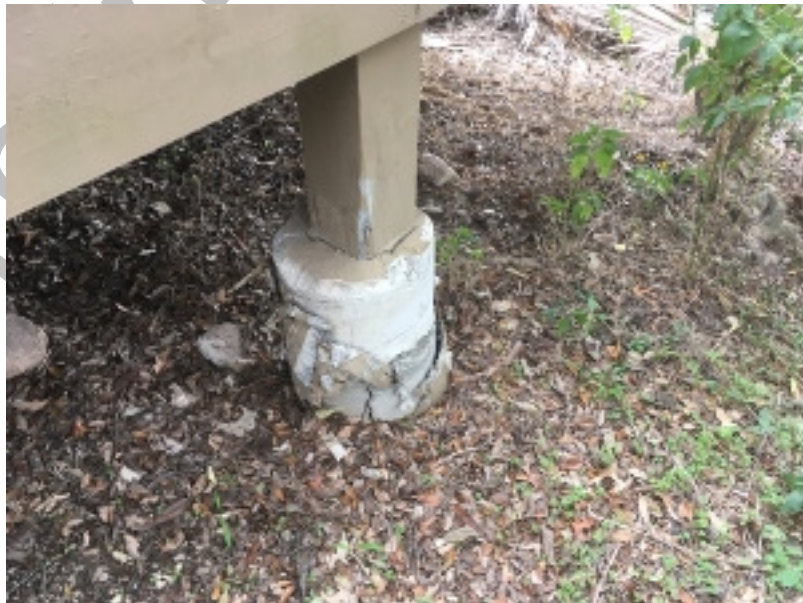
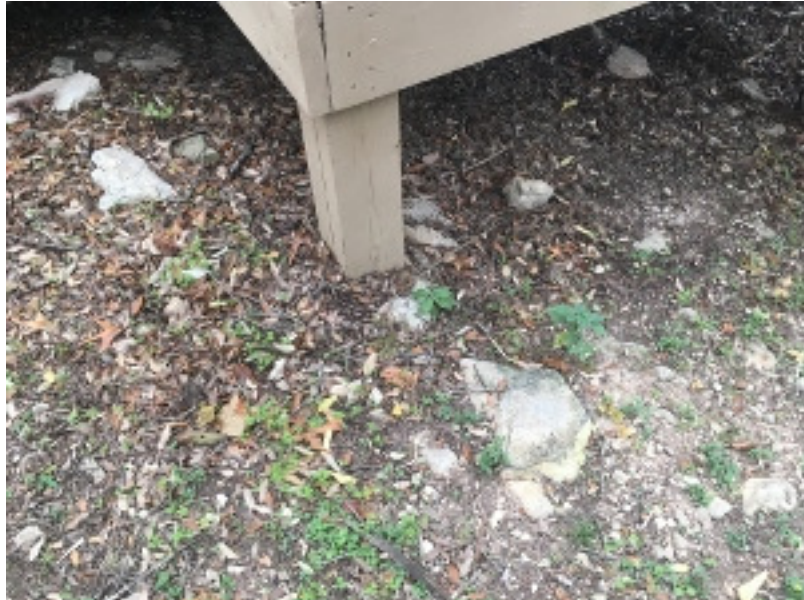
- THE POSTS / PIERS FOR THE OBSERVATION DECK – Have concrete poured around them, which can trap water against the posts / have wood to ground contact. The concrete is cracked / damaged.
