## PROPERTY INSPECTION REPORT

**Concerning:** Property Address **Insp.#: 191127 - A** **Agent:**  
(Address or Other Identification of Inspected Property)

**By:** Danny Pitts, TREC License # 4717 **11/27/19**  
(Name and License Number of Inspector) (Date)

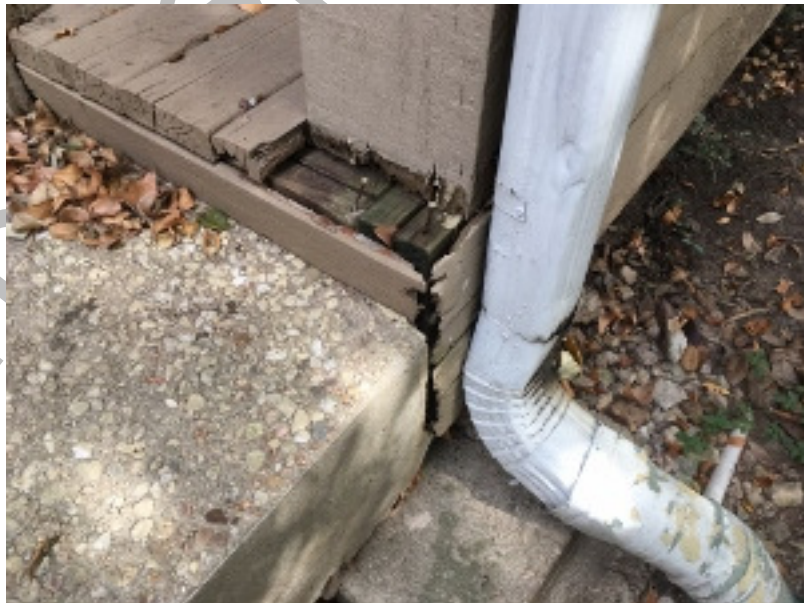
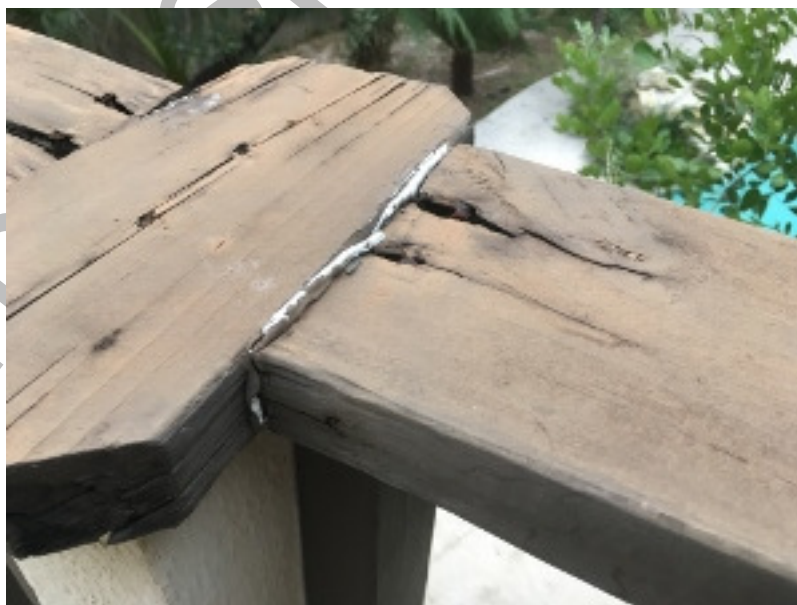
- THERE IS DAMAGE / DECAY – At various locations at the floor boards, railings & pickets, especially at the master deck.

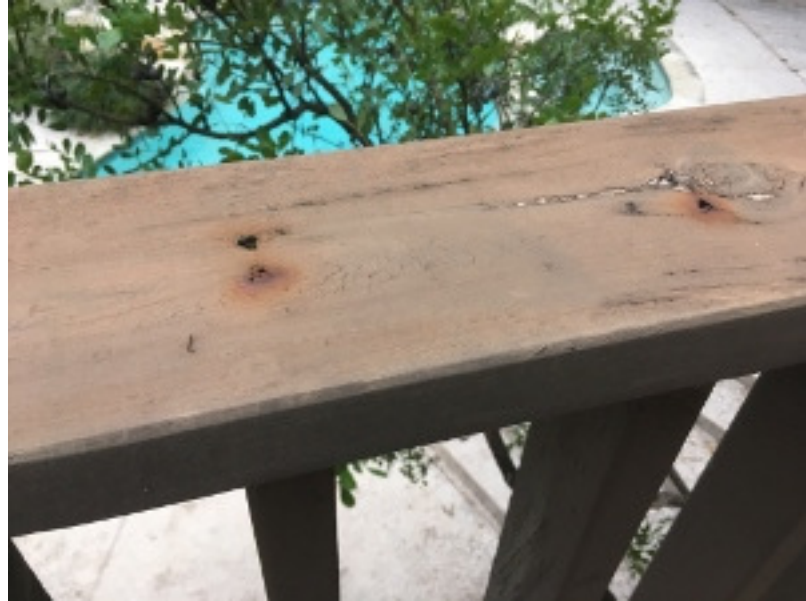
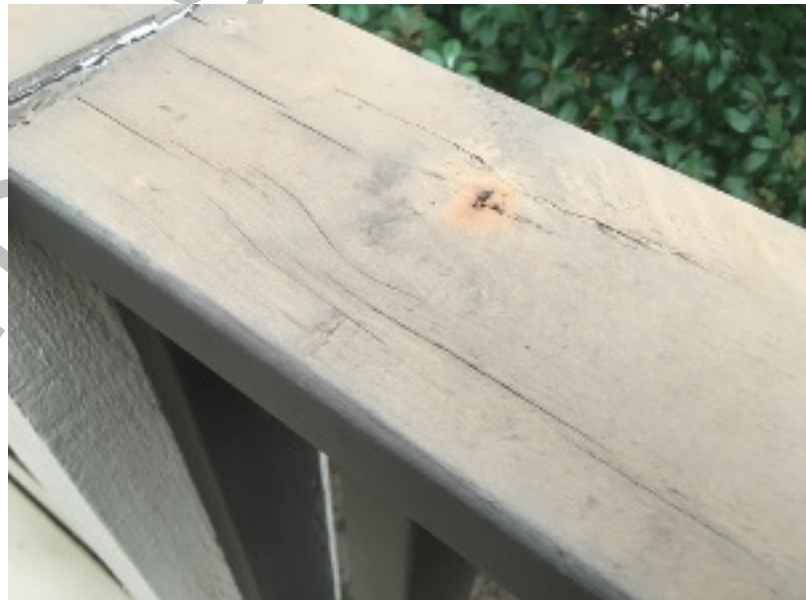
- THE NAILS ARE NOT GALVANIZED / ARE RUSTING – At the railings at various locations.

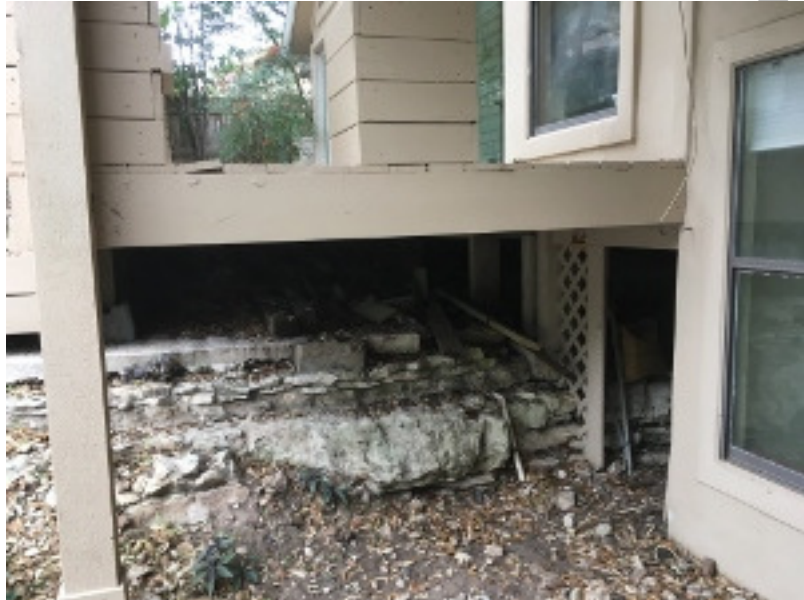
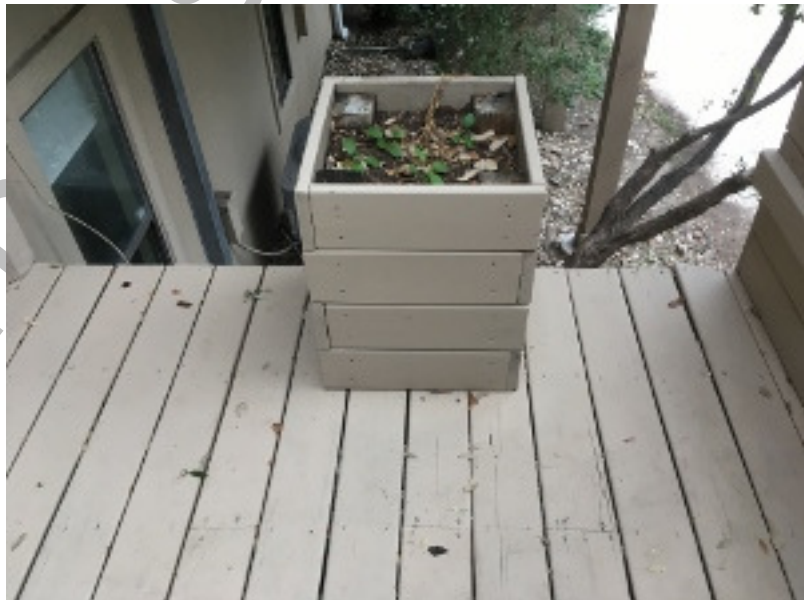
- THE REAR PORCH / DECK RAILING - Is missing at the left of the doors. When porch / deck heights exceed 30 in., a railing is required & the pickets must be 4 in. apart maximum.

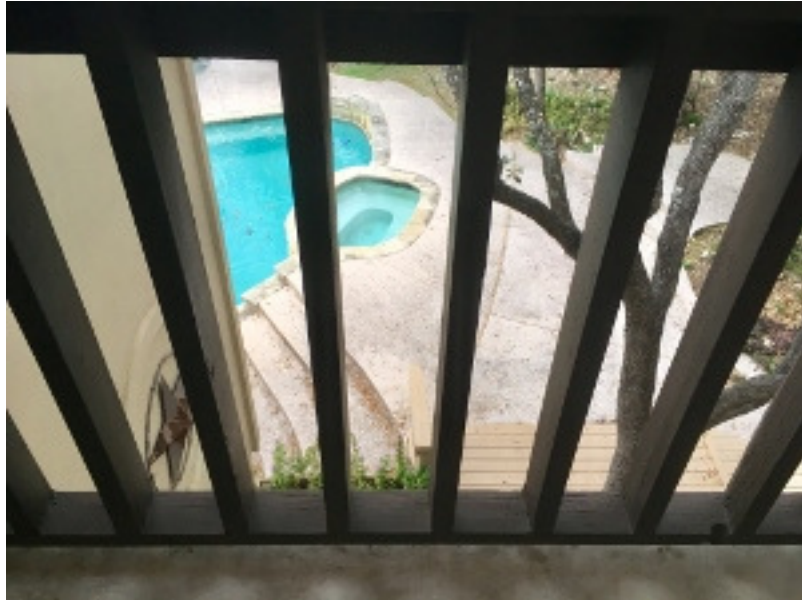
- THE LOFT PORCH / DECK RAILING PICKETS – Are not 4 in. maximum apart.

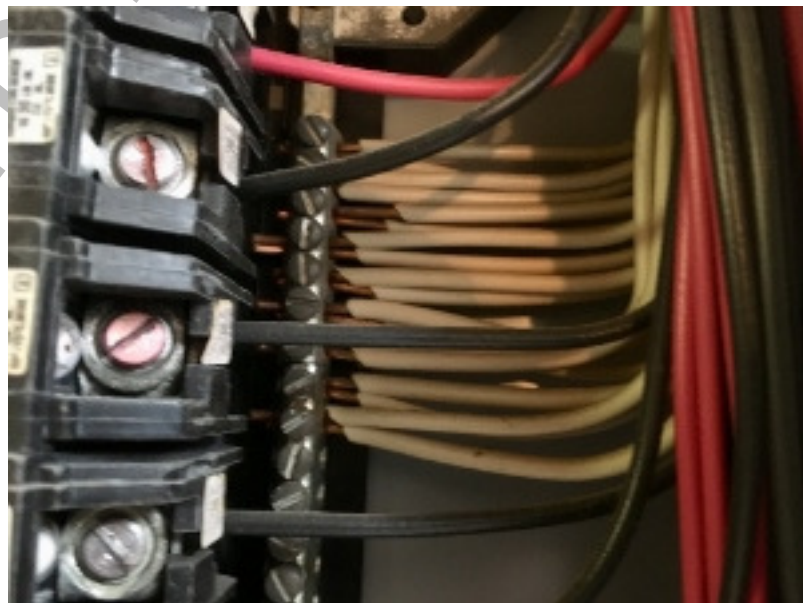
- THE SERVICE IS APPARENTLY GROUNDED FROM THE METER BOX. A GROUND WIRE WAS NOT OBSERVED IN EITHER OF THE BREAKER BOXES IN THE GARAGE - Did not observe the termination of the ground wire to a ground rod or the slab.
- THE MAIN BREAKER BOX –The second ground wire to a ground rod / the slab is missing (required as of the 1997 code).
- The box has double lugged neutral wires (more than 1 wire connected to the screws) at the buss bar, which is a potential fire hazard.

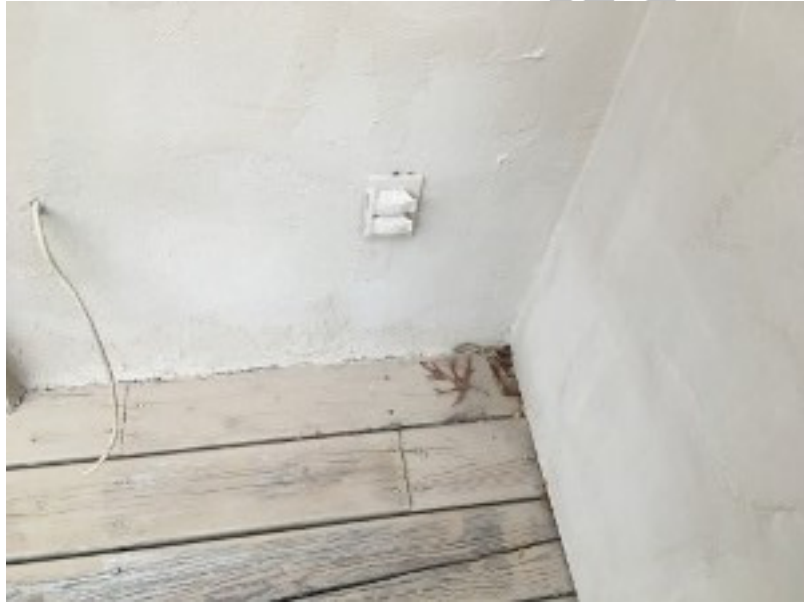
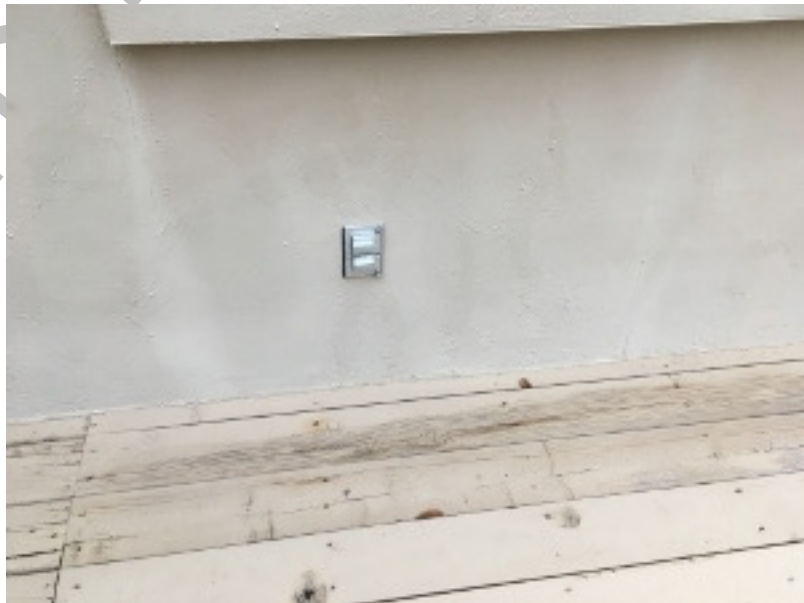
- ADD G.F.C.I. OUTLETS - To all the outlets at the kitchen countertops.
- ADD G.F.C.I. BREAKERS - For the kitchen appliances including the dishwasher & the disposal outlets (required as of the 2015 code) & all the laundry room outlets (required as of the 2015 code).
- THE WEATHER PROOF OUTLET COVERS AT THE EXTERIOR OUTLETS – Are not the “bubble type covers” required for “wet locations” (where there is not a roof protecting the outlets) at various locations.

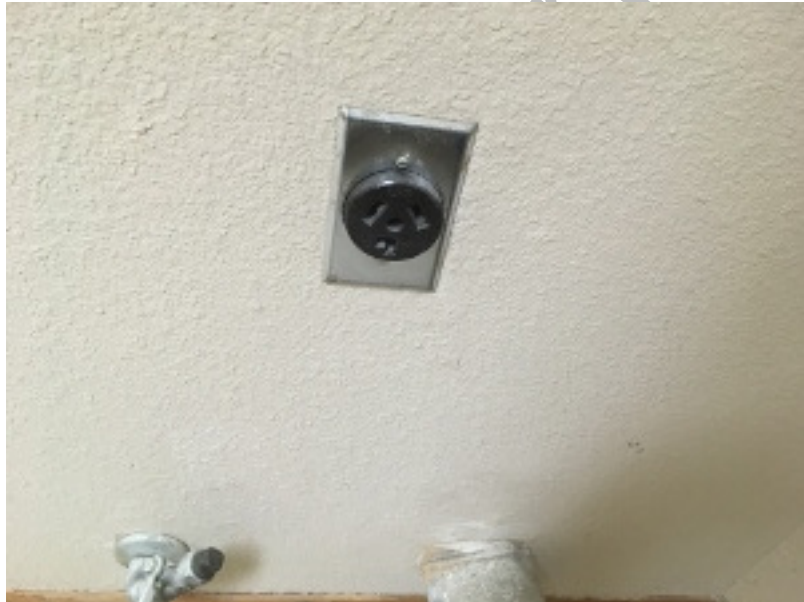
- THE LIGHT IS NOT WORKING – At the downstairs den closet.
- THE CAN LIGHTS – Verify that the can lights are rated for installation under insulation where applicable.
- THERE ARE LOOSE OUTLETS – At various locations including at the bar sink, the right rear of the garage, the left rear of the living room, the downstairs hall & the master bath.
- THERE ARE DEAD OUTLETS – At the right of the fireplace in the downstairs den & on the Jacuzzi.
- THE 220 AMP CLOTHES DRYER OUTLET – Is not a 4 prong grounded outlet (introduced in the 1997 code).

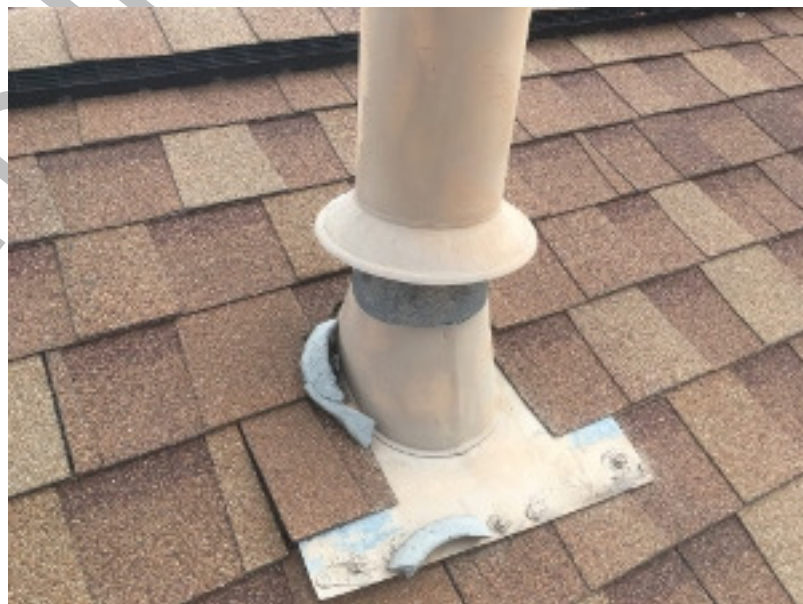
- THE VENT PIPE RAIN COLLAR - Lower the rain collar down to the flashing cone & reseal the rain collar to the vent pipe to prevent water leakage into the attic above the garage.

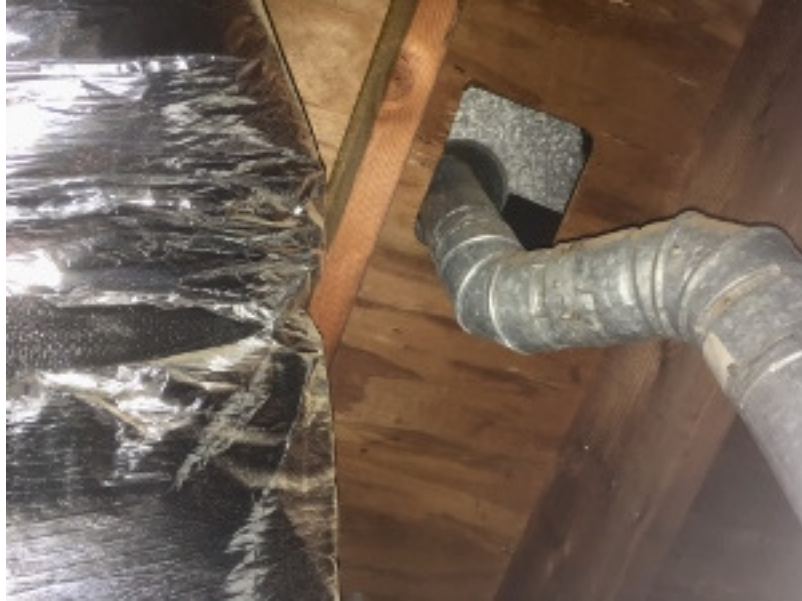
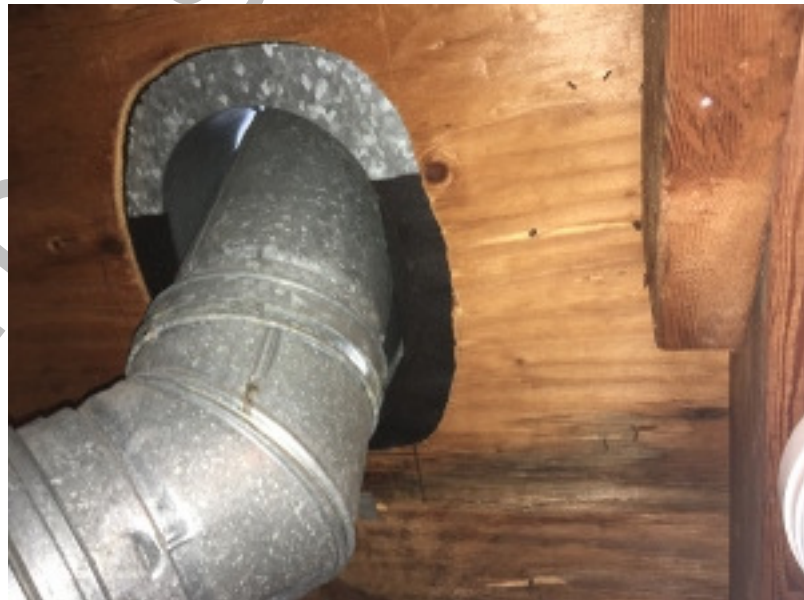
- EACH VENT PIPE – Does not have a 1 inch minimum clearance from combustible materials at the roof decking / roofing materials, which is a fire hazard.

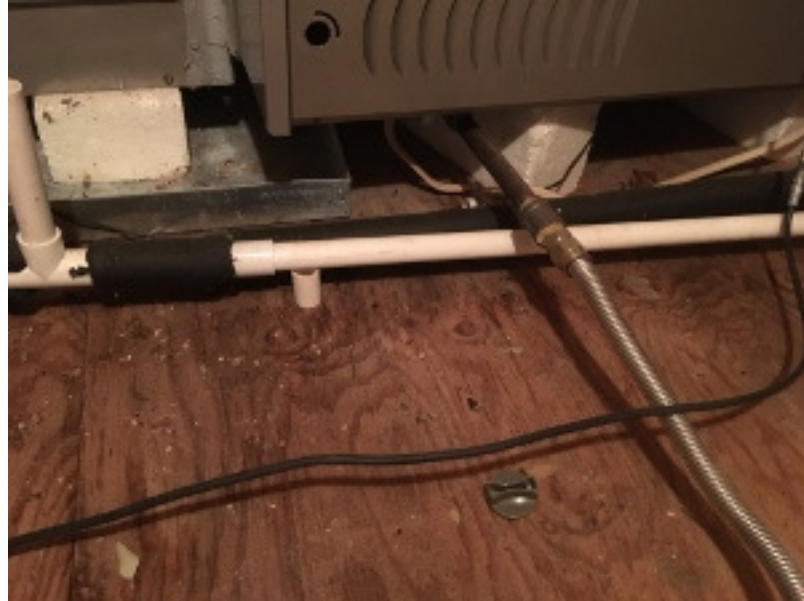
- THE CONDENSATE DRAIN LINES - Do not terminate 3 ft. away from the slab.
- Each entire drain line is not insulated in the attic (required as of the 2000 code).

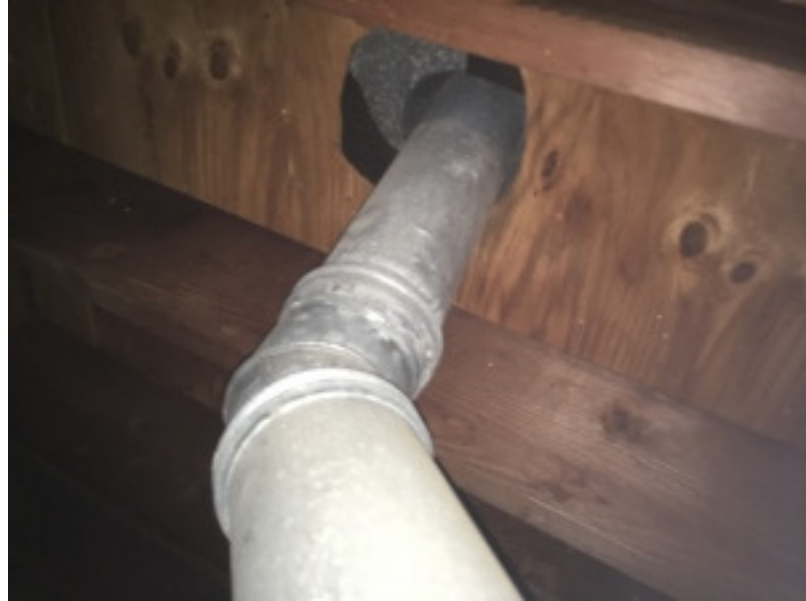
- EACH VENT PIPE – Does not have a 1 in. minimum clearance from combustible materials at the roof decking / roofing materials, which is a fire hazard.

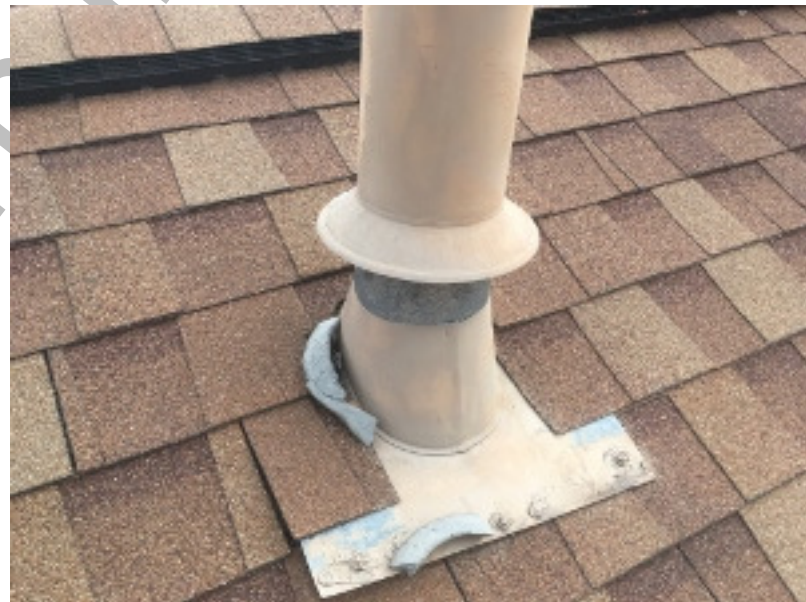
- THE VENT PIPE RAIN COLLAR – Lower the rain collar down to the flashing cone & reseal the rain collar to the vent pipe to prevent water leakage into the attic above the garage.

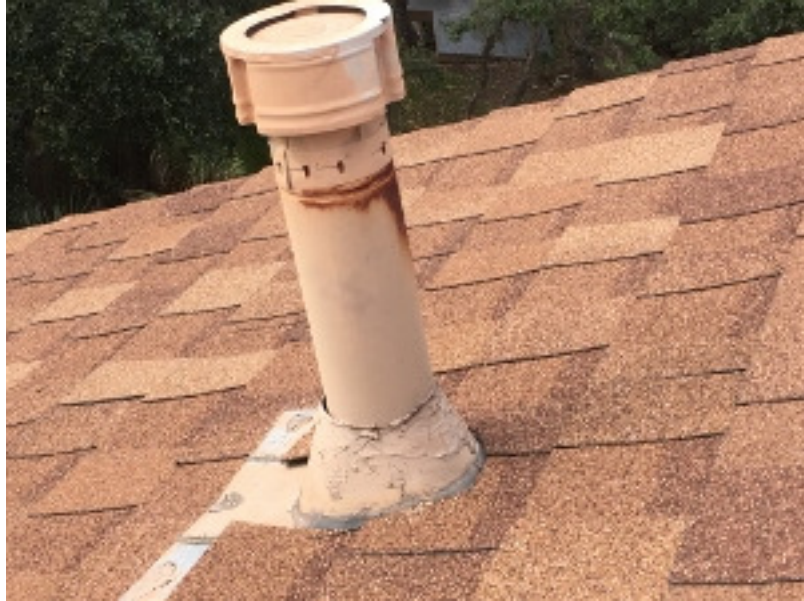
- THE VENT PIPE RAIN COLLAR – The rain collar to prevent water leakage into the attic is missing at the left rear.
- THE LEFT REAR VENT PIPE - Is rusting above the roof.

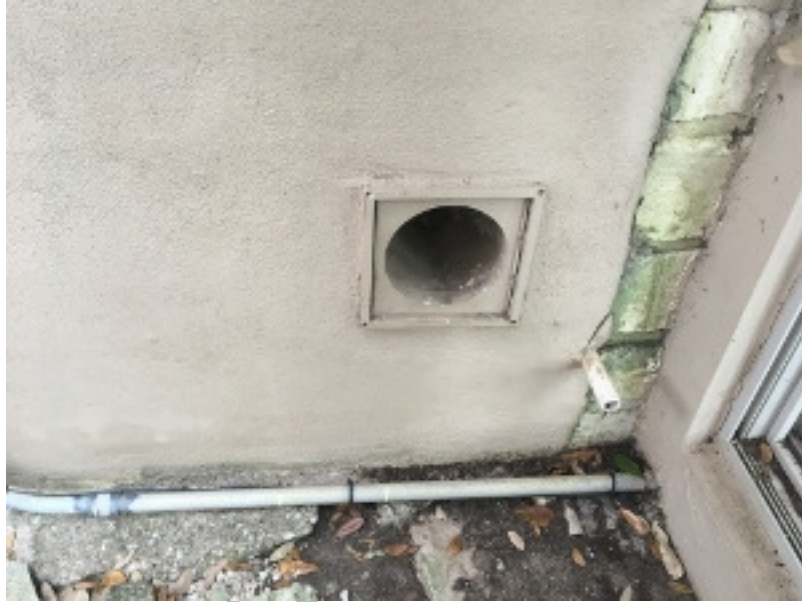
- THE KITCHEN VENT PIPE – The cover for the vent is missing. The pipe is prohibited corrugated pipe.

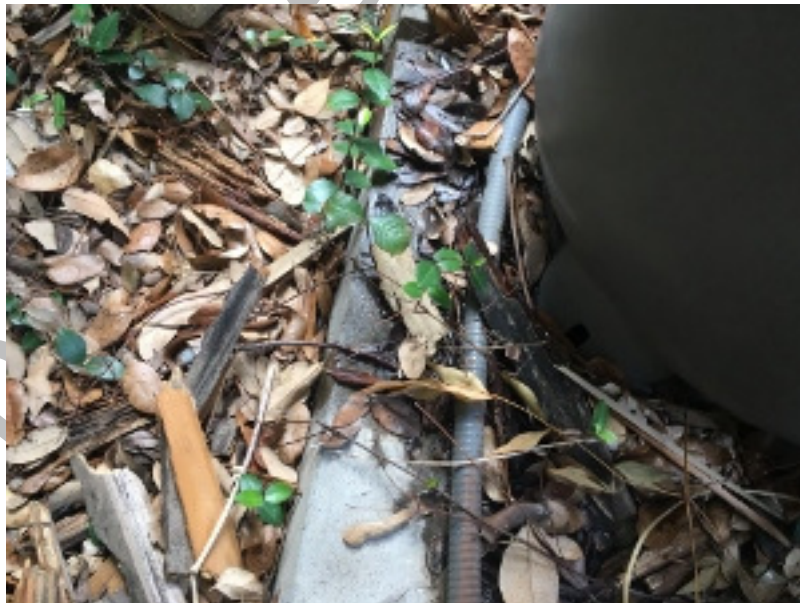
- THE MOTOR – The motor & other equipment are not bonded as required. The motor should be bonded back to the main breaker box.
- THE HEATER - Was not tested.
- THE POOL SURFACE - Is damaged.
- THERE ARE WATER LEAKS – At the pool equipment.

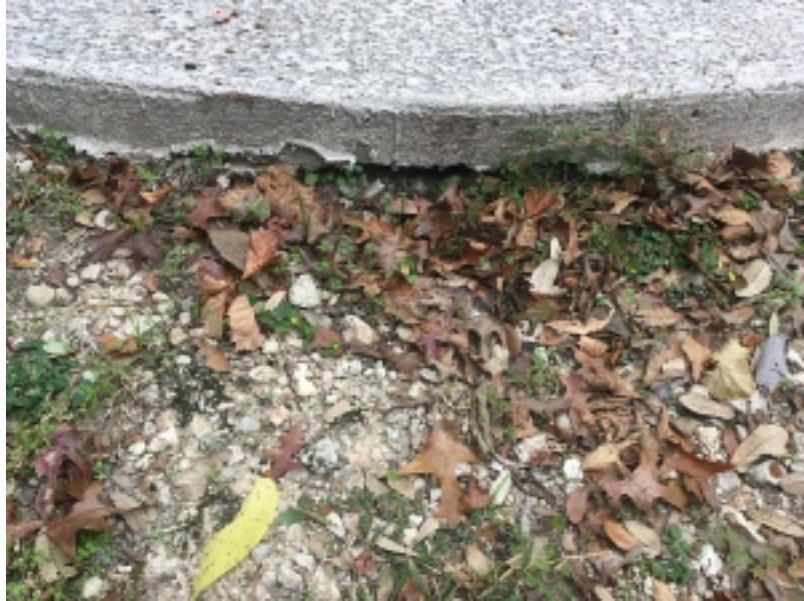
- THE DECK AROUND THE POOL – Does not have a perimeter beam.
-

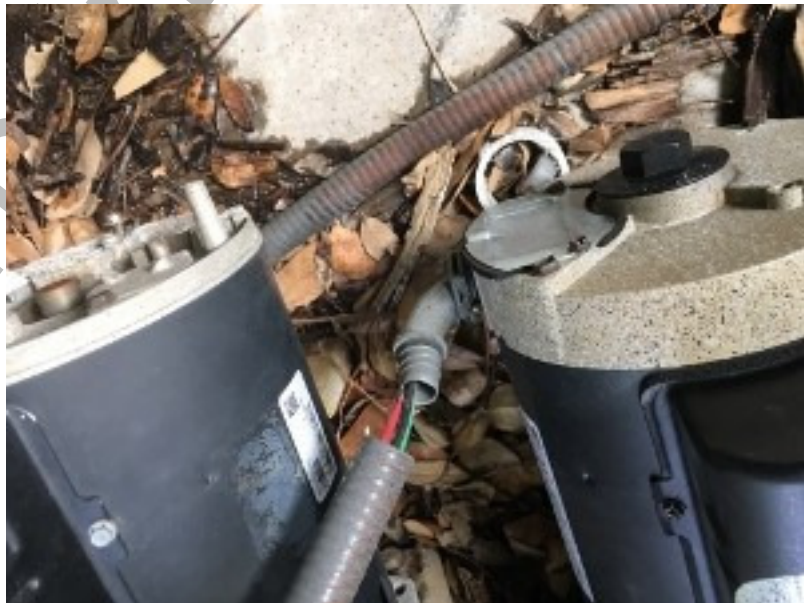
- SPA & POOL MOTORS – There is loose conduit on the wiring.

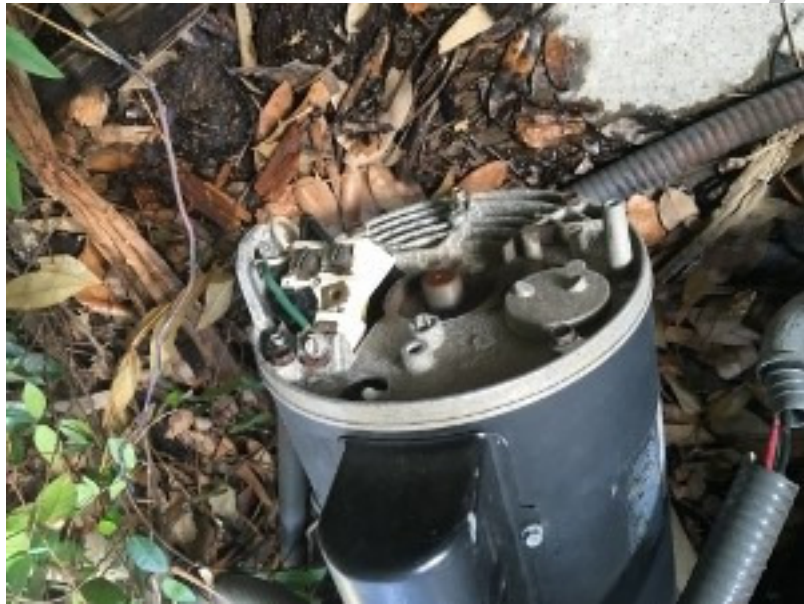
- There is exposed wiring at the right motor.
