PROPERTY INSPECTION REPORT

Commercial Property Address

Danny Pitts, TREC License # 4717

Report Identification: Sample Commercial Property**Insp.#**

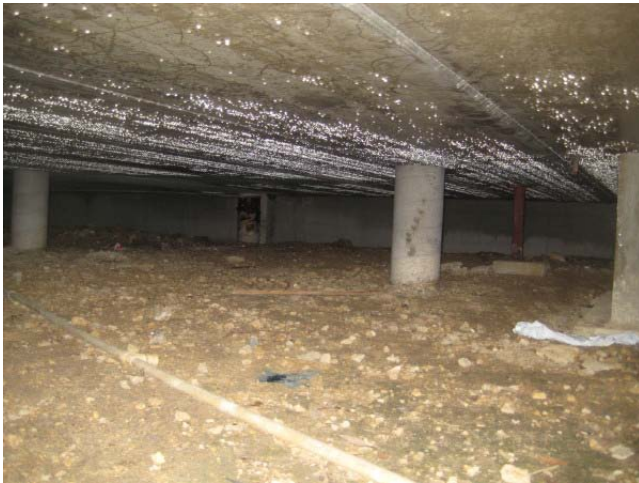
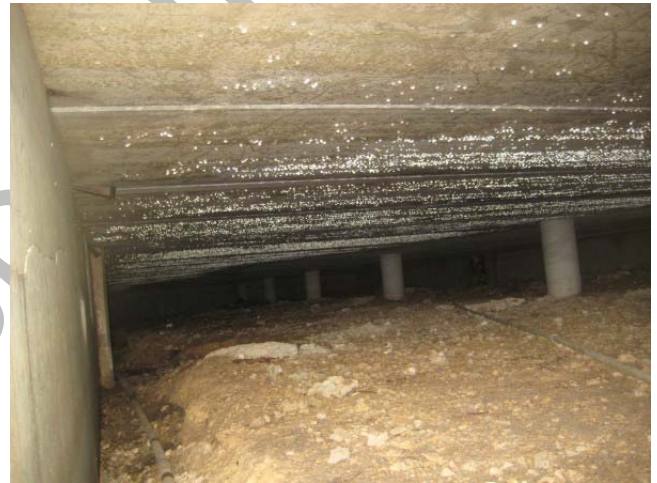
- THE CONCRETE SKIM COATING - Is broken at various locations.
- THE SLAB HAS A COLD JOINT – At Bldg. # 2 (a cold joint is created when an addition slab is poured against an existing slab). It is unknown if the 2 slabs are properly tied together.
- THERE IS A PIER & BEAM FOUNDATION AT THE RIGHT REAR – The piers are poured concrete, depth of the footings is unknown. A perimeter beam / footings for the exterior wall do not appear to be present.

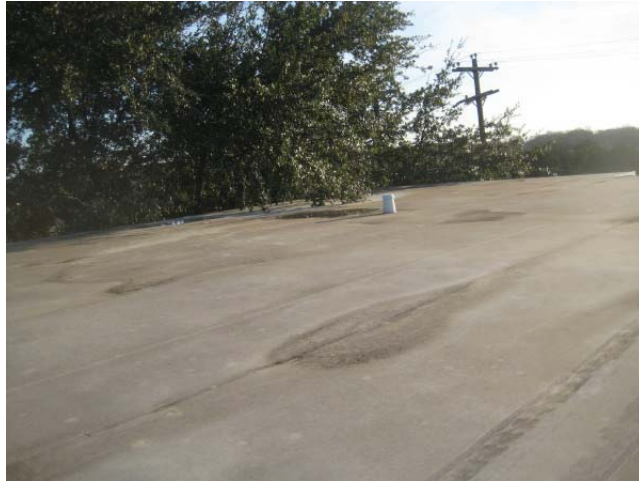
- TRIM TREE BRANCHES – 4 ft. away from the roof.

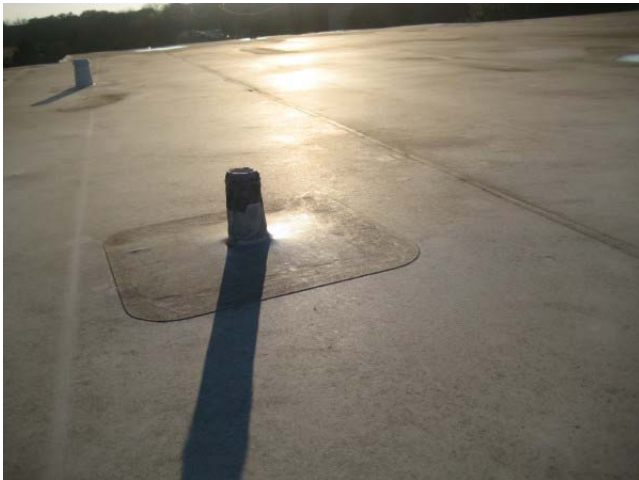
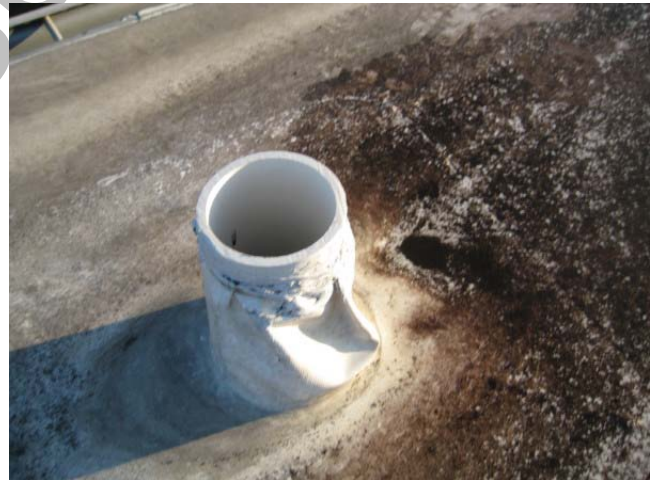
- THE PLUMBING VENT PIPE FLASHING BOOTS – The tops of 2 of the vent pipe flashings are not turned down inside of the pipes properly.

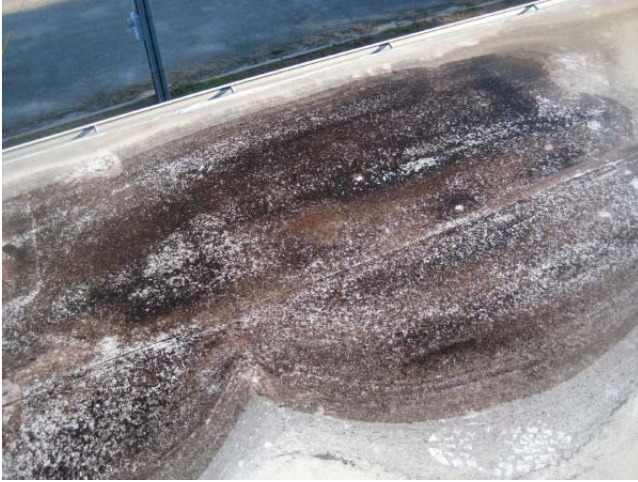
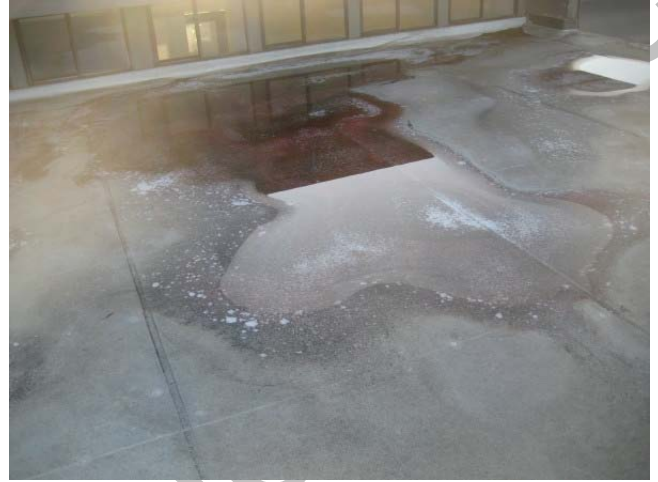
- THERE IS WATER STANDING ON THE ROOF – At various locations.

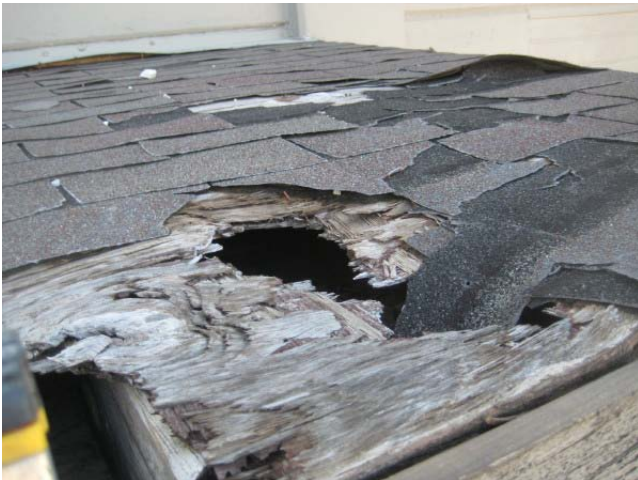
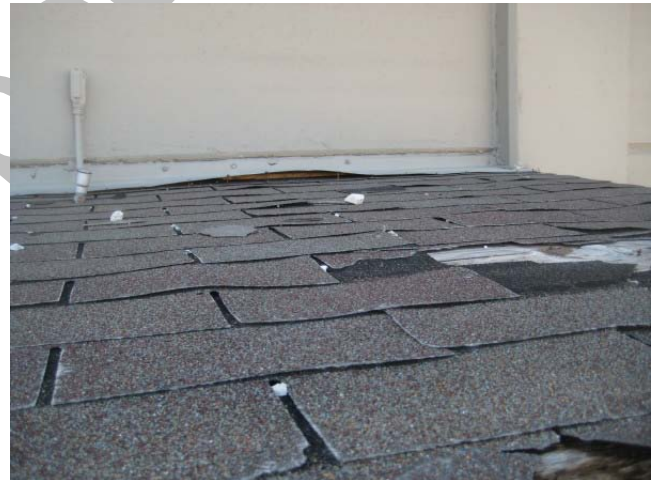
- DAMAGED / MISSING SHINGLES – At the rear porch.

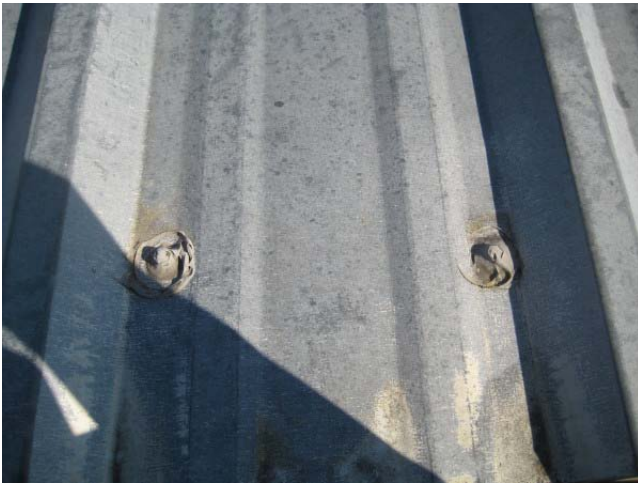
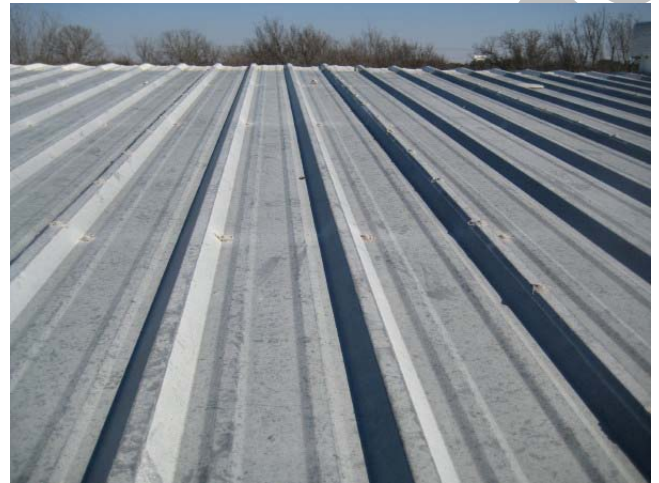
- THE SCREWS ON THE METAL ROOF OF BLDG. 2 – Are installed in the valleys rather than on the ribs. It will be necessary to periodically tighten the screws to prevent water penetration. The screws have been caulked at various locations.

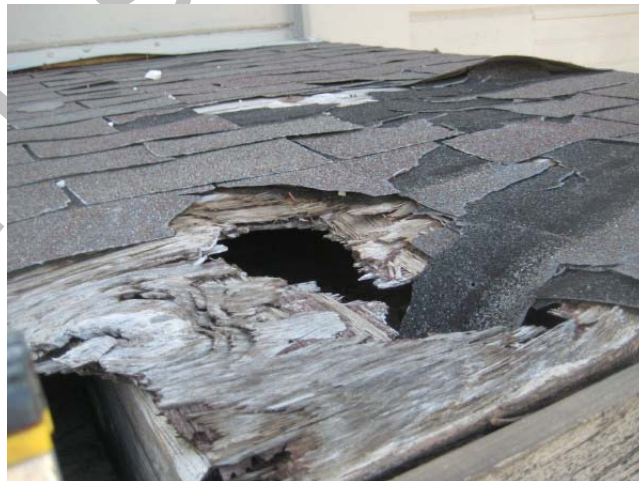
- THE ROOF DECKING HAS WOOD ROT – At the rear porch.

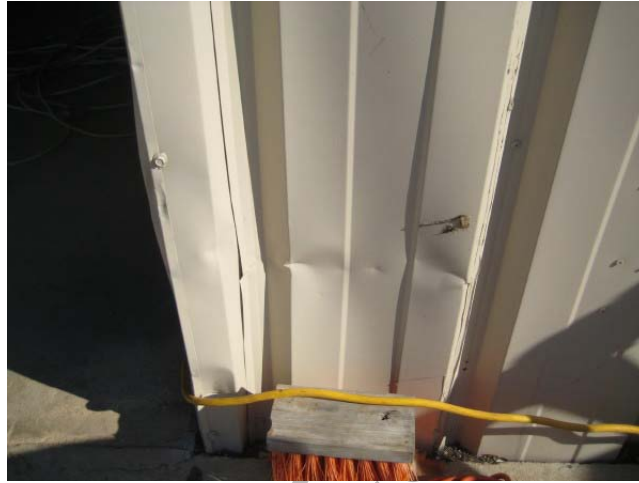
- **DAMAGED METAL SIDING** – At various locations of Bldg. 2. There are loose wall screws & screws with damaged / missing rubber washers at various locations.

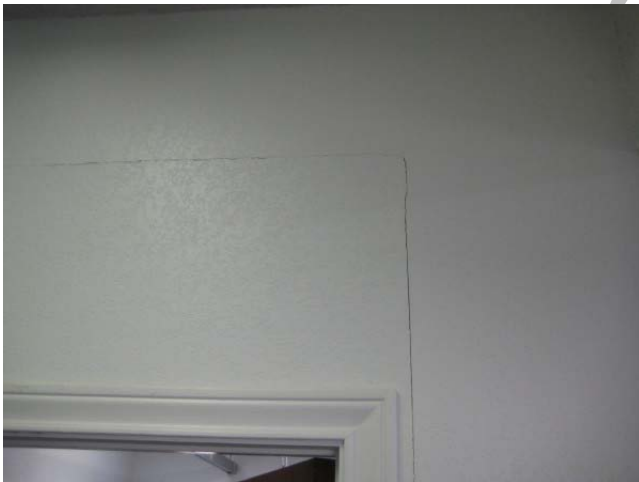
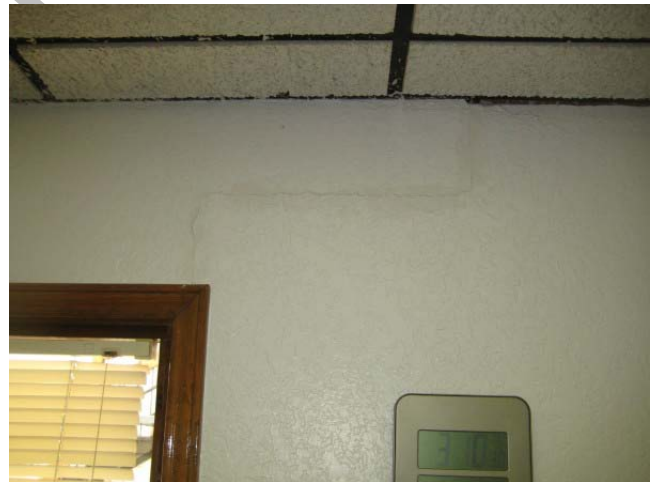
- **RUSTED WALL FRAMING** – At Bldg. 2.
- **STAIR STEP CRACKS IN THE ROCK** – At the front right of Bldg. 2. Seal the cracks to prevent water penetration.
- **MAIN BLDG.: SHEETROCK SETTLING CRACKS** – At various wall locations including at the rear hall, the entry hall & room 9.

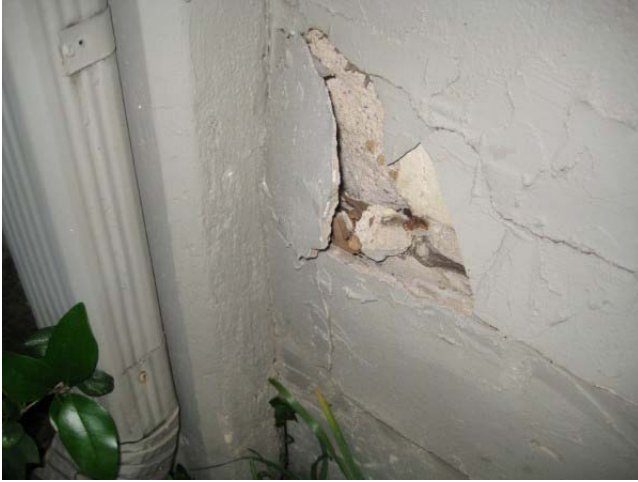
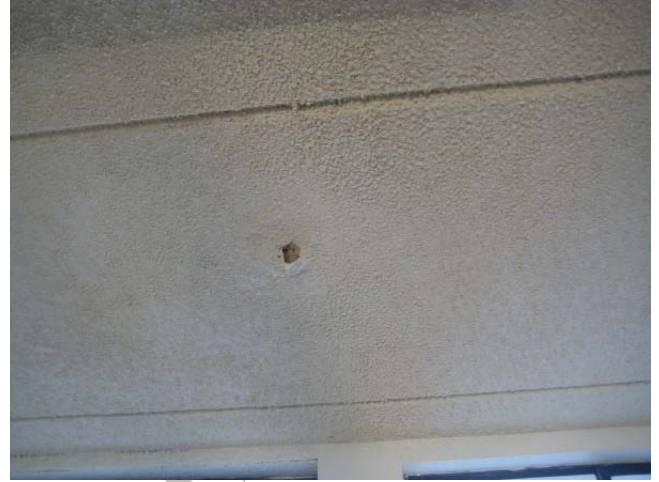
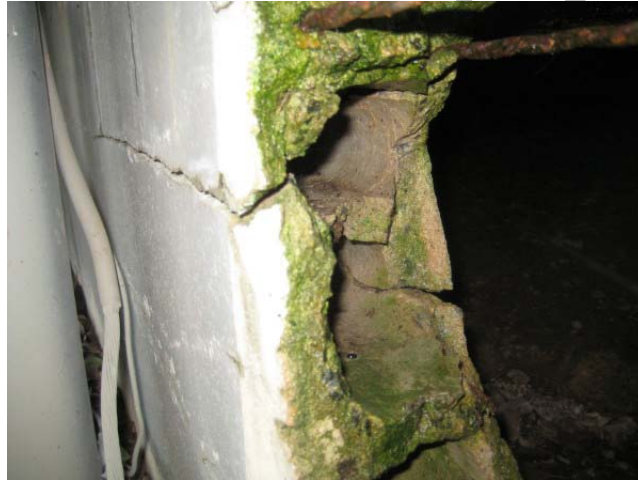
- THE TILT WALL SIDING PANELS – Are damaged / cracked at various locations including at the access door to the crawl space. The panels appear to be buried at the right & rear.

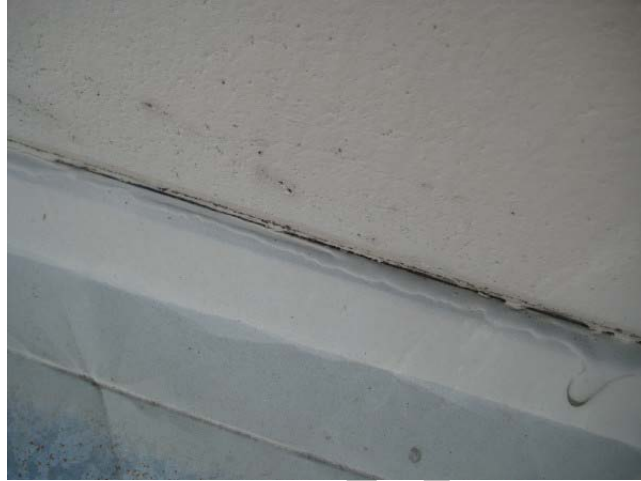
- RECAULK – At the windows, the trim & the siding connections to the roof at various locations (to prevent water penetration). Seal all the wall penetrations.

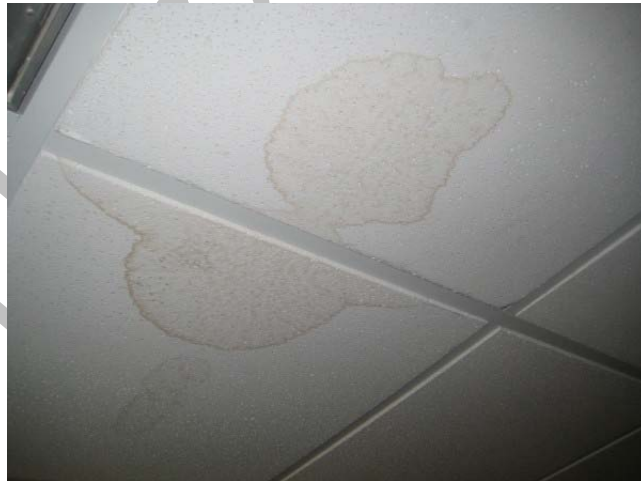
- STAINED / LOOSE CARPET – At various locations.
- WATER PENETRATION STAINS – At the entry, the upstairs foyer & room 13, could not determine if the stains are still active.

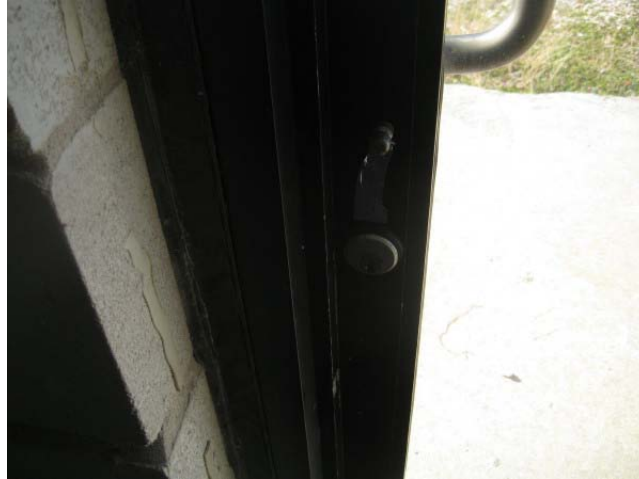
- THE WEATHER STRIPPING IS MISSING – At the attic door in the upstairs foyer.
- THE DOOR STOPS - Are missing at various locations.
- THE DOOR BINDS ON ITS FRAME – At room 6.
- THE DOOR DOES NOT LATCH – At the bathroom in Bldg. 2.
- BROKEN HANDLE – At the front door of Bldg. 2.

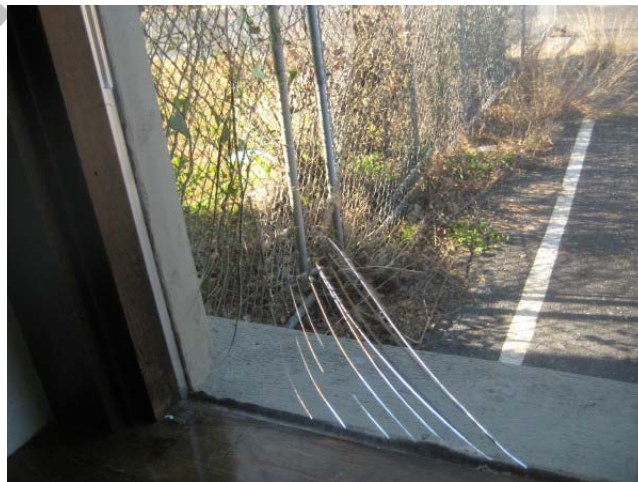
- FOGGED WINDOWS - At various locations.
- BROKEN WINDOWS – At the office in Bldg. 2 & at room 6.

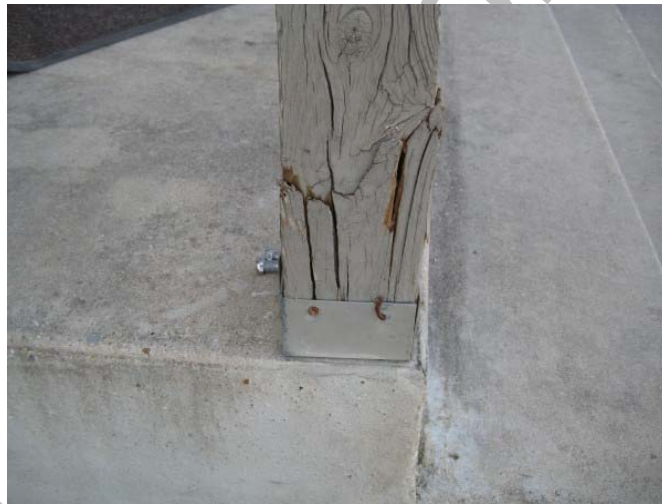
- THE REAR PORCH POSTS - The bottoms of the posts are damaged / have wood rot.

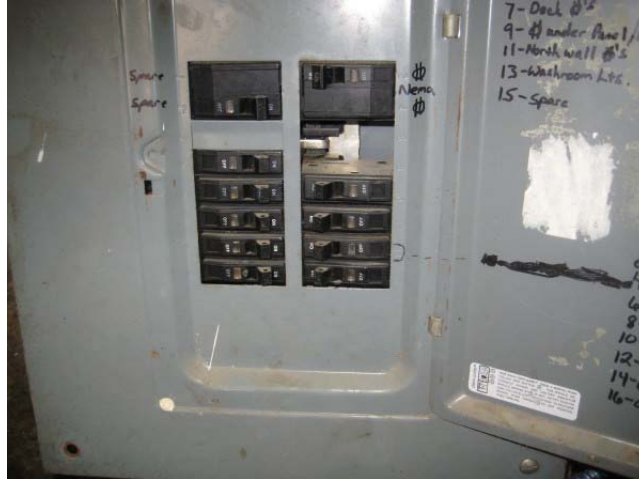
- THE MAIN BREAKER BOX IN BLDG. 2 - Has 2 missing knock out spacers in the front panel.

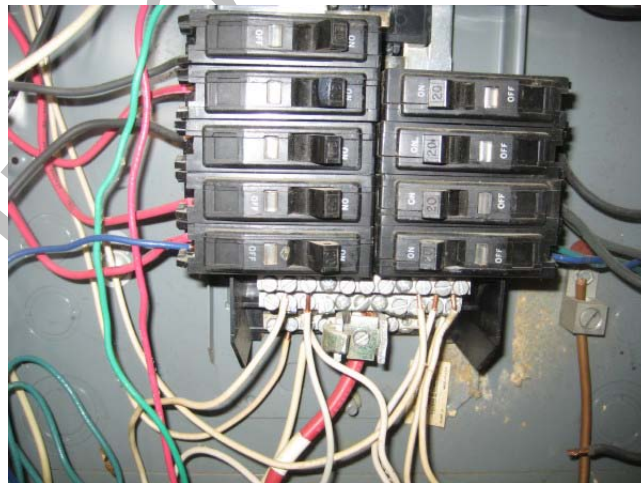
- Has 2 double lugged breakers, add 2 breakers & separate the (2 wires) double lugged breakers to 1 wire per breaker.

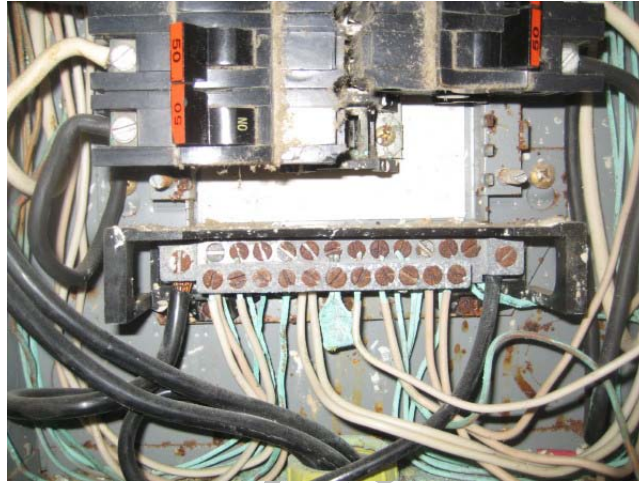
- 5 OF THE BREAKER BOXES IN THE MAIN BLDG. – Are Federal Pacific boxes (consult an electrician about potential hazards). The box in room 13 is corroded. The boxes have double lugged neutral wires (more than 1 wire connected to each screw on the neutral buss bar) at various locations.

- ALL THE BREAKERS - Are not labeled.
- HAVE THE ELECTRICAL SYSTEM EVALUATED BY AN ELECTRICIAN.

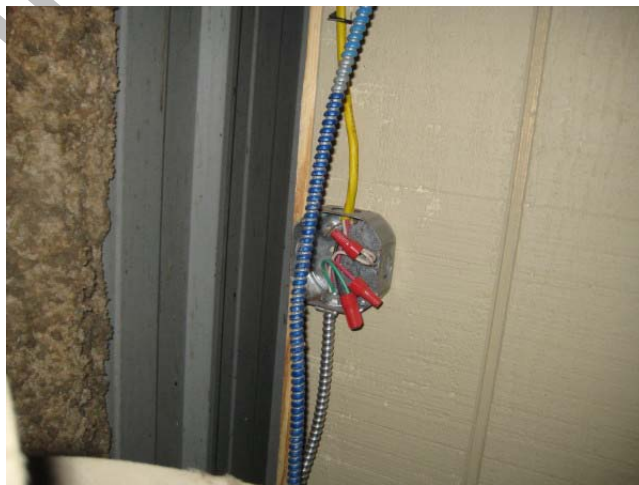
- OPEN WIRE SPLICE - Not in a junction box with a cover plate at the AC in the entry.

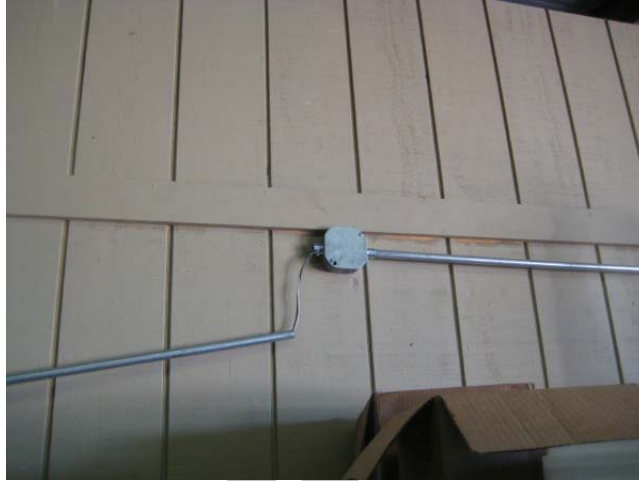
- THE WEATHER PROOF PLUG COVERS AT THE EXTERIOR PLUGS – The cover is missing at the front left of Bldg. 2. The covers are not the “bubble type covers” required for “wet locations” (where there is not a roof protecting the plugs).
- ALL EXPOSED ELECTRICAL WIRES – The conduit pipe is loose at the right of Bldg. 2.

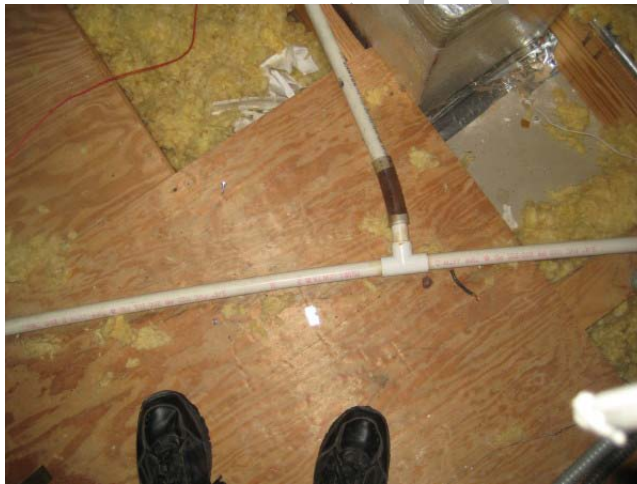
- THE CONDENSATE DRAIN LINES - Did not locate the terminations of some of the lines. The drain lines are not insulated in the attic (required as of the 2000 code). There are 2 drain lines converging into 1 line. The size of the line has not been increased to accommodate the additional water flow. The drain lines are very long.

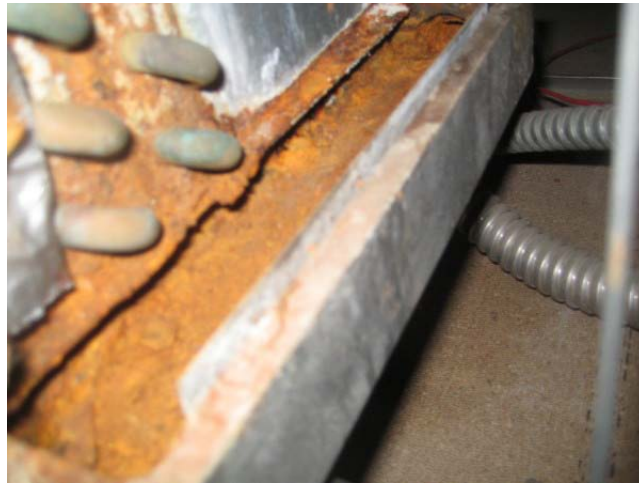
- THE SECONDARY OVER FLOW PANS - The pan is rusting at the entry unit. Have the pan evaluated. The pans do not extend 1½ in. beyond all 4 sides of the evaporator coil at various locations.

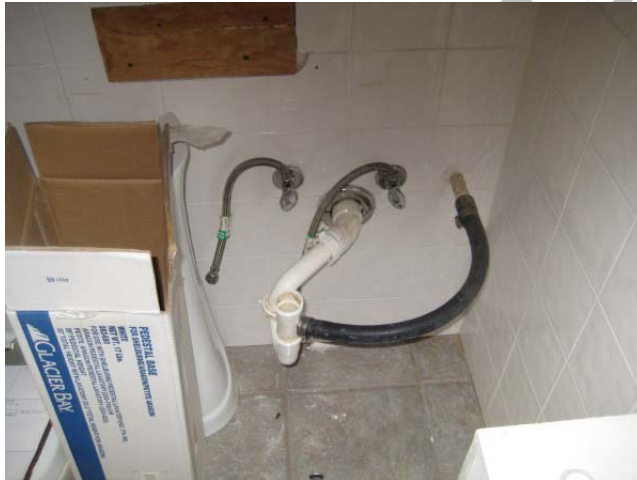
- THE SINK FAUCET – Hot / cold are reversed at the right rear hall bath.
- THE SINK IS LOOSE ON THE WALL – At the right rear hall bath.
- THE SINK IS MISSING – At the left rear hall bath.
