## PROPERTY INSPECTION REPORT

**Concerning:** Property Address **Insp.#: 191127 - A** **Agent:**  
(Address or Other Identification of Inspected Property)

**By:** Danny Pitts, TREC License # 4717 **11/27/19**  
(Name and License Number of Inspector) (Date)

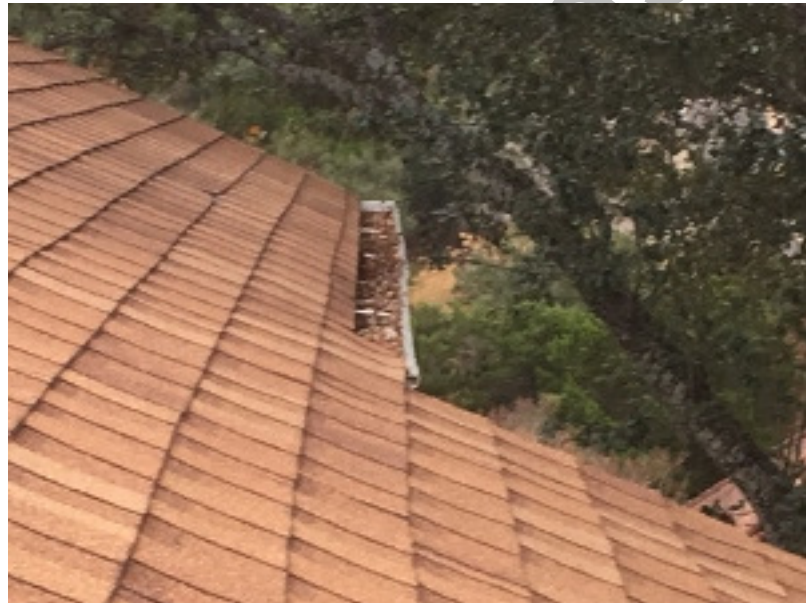
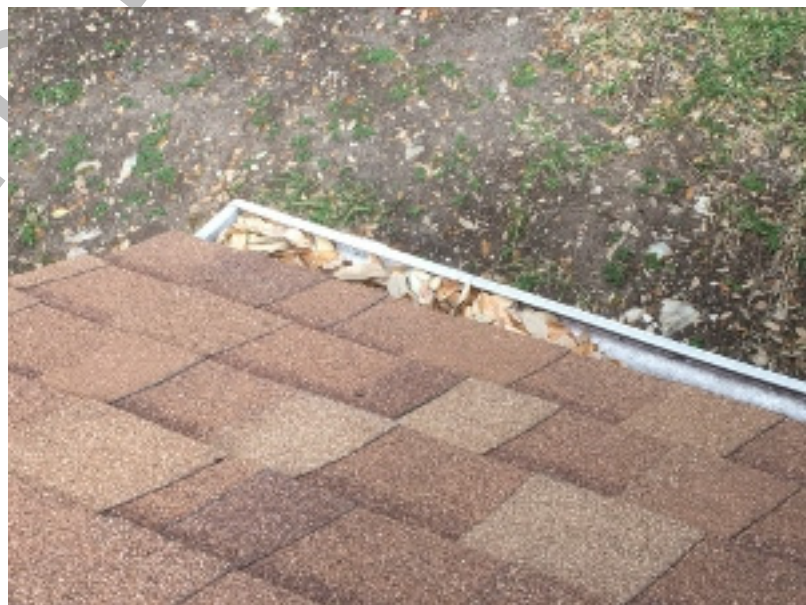
- THE GUTTERS – Remove all debris from the gutters.

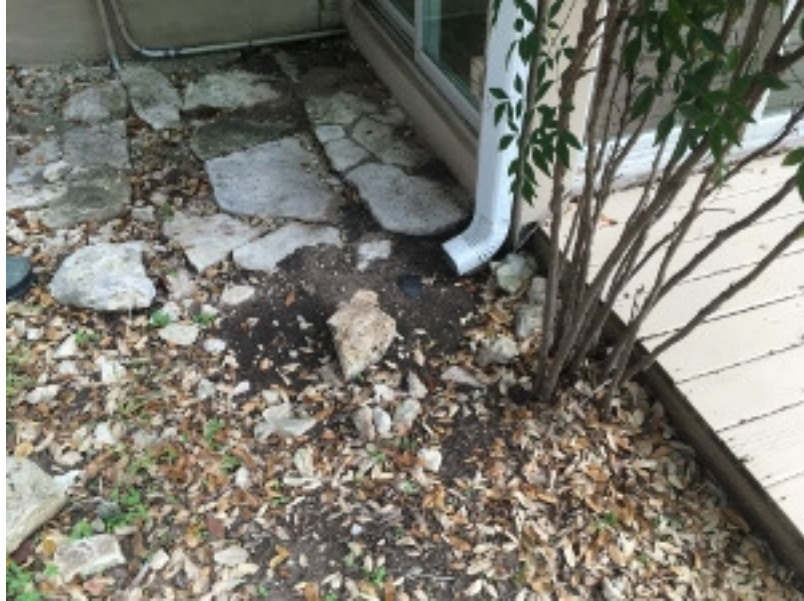
- THE GUTTER DOWNSPOUTS – Add splash blocks or extensions at all the downspouts that terminate on the ground.

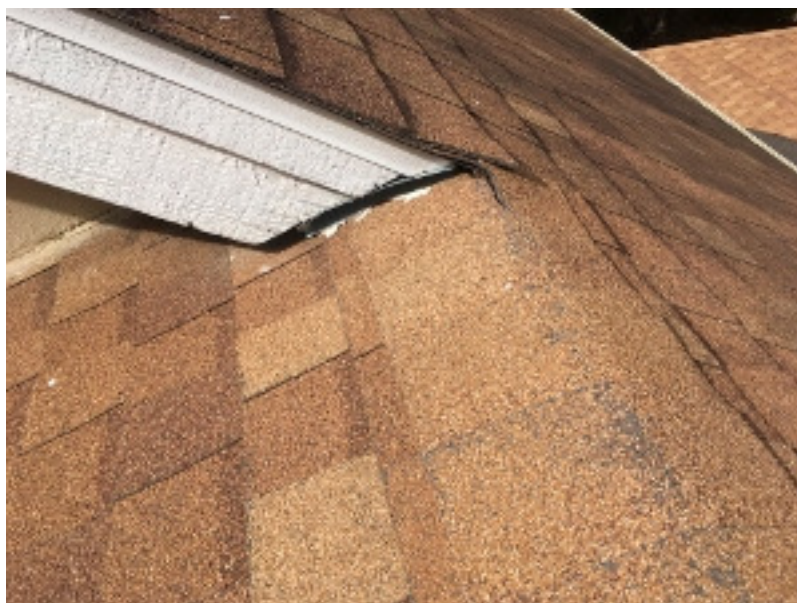
- THERE ARE MULTIPLE DAMAGED / WORN RIDGE CAP SHINGLES – At various locations.

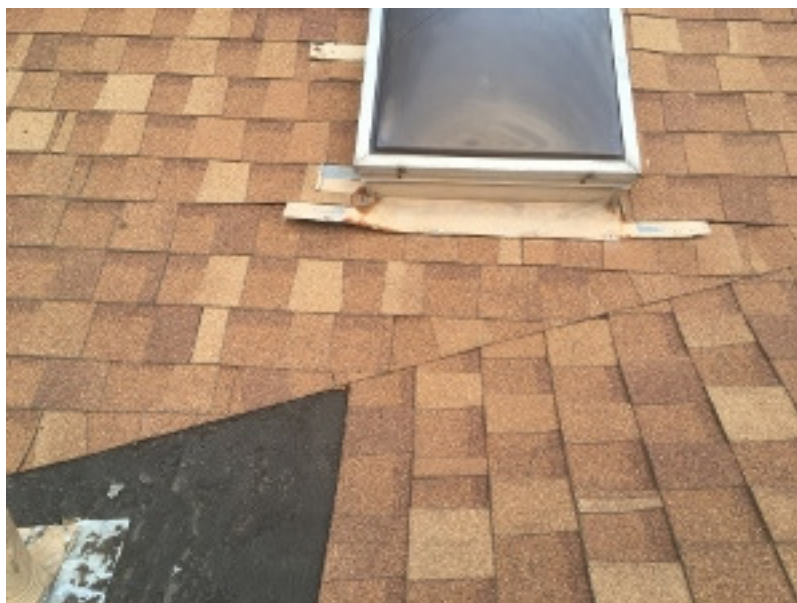
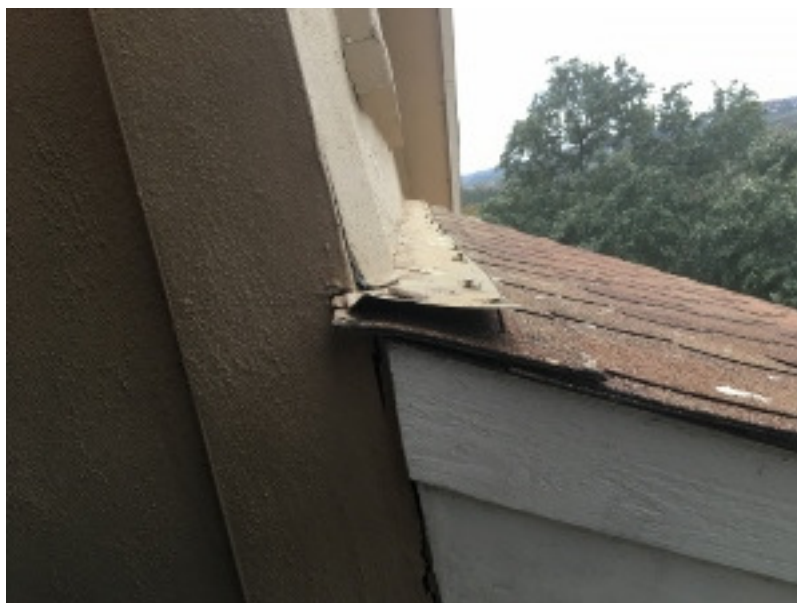
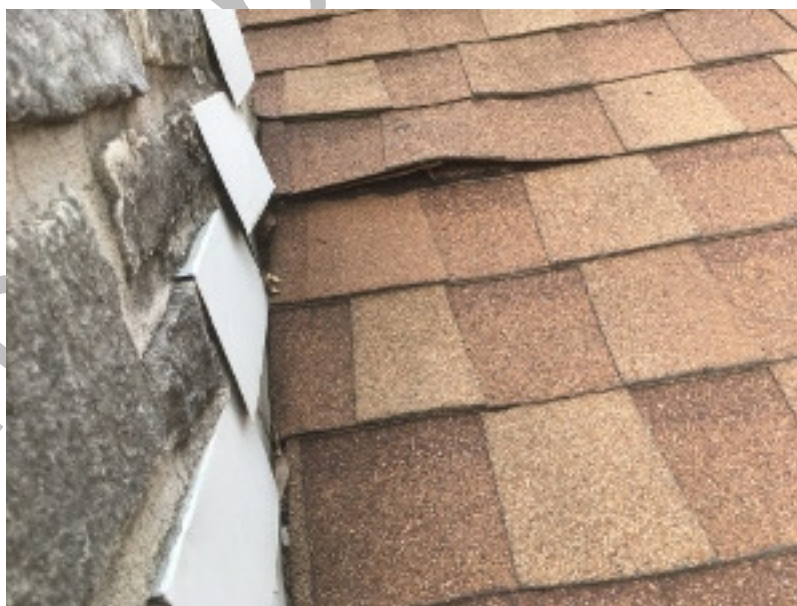
- THERE ARE LOOSE / RUSTED FLASHINGS – At various locations including at the skylight, the left rear & the chimney.

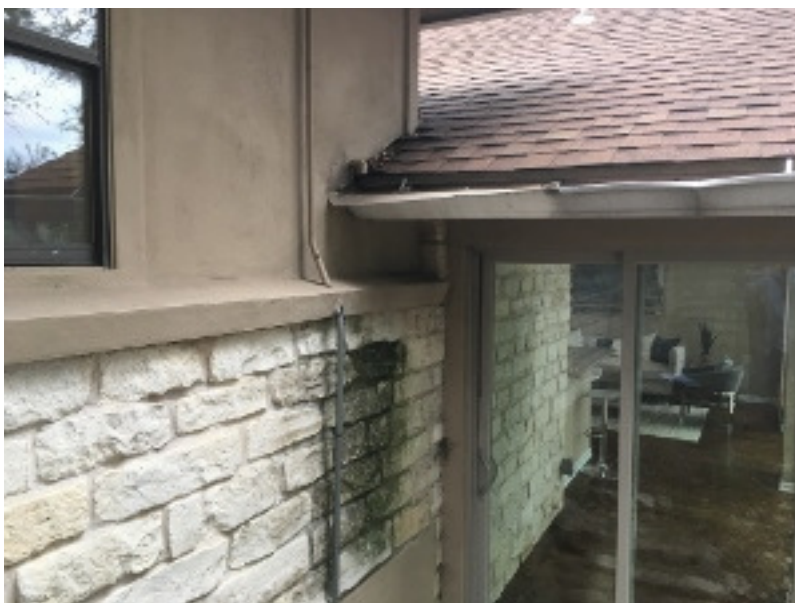
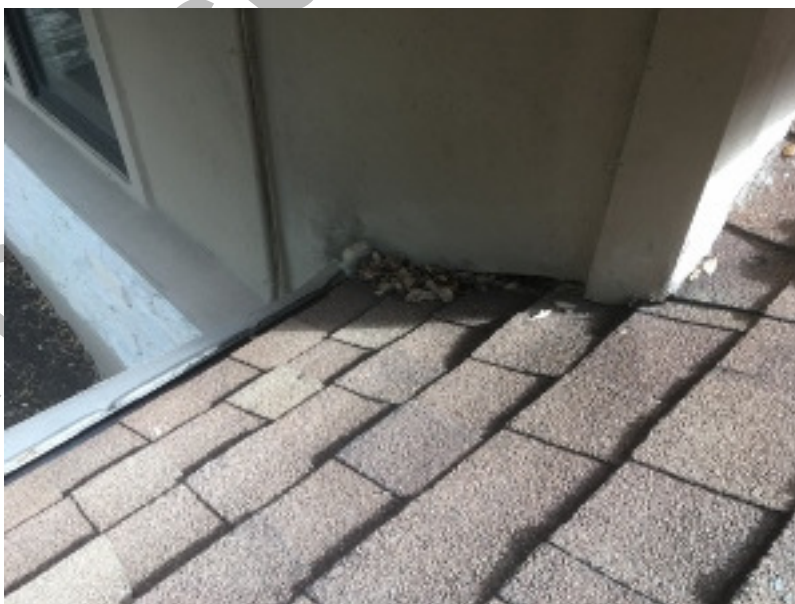
- THERE ARE MISSING FACTORY BUILT KICKOUT FLASHINGS – At the roof / wall connections at various locations including at the left of the garage & the right rear where a wall extends below the roof termination (to prevent water penetration behind / into the siding).

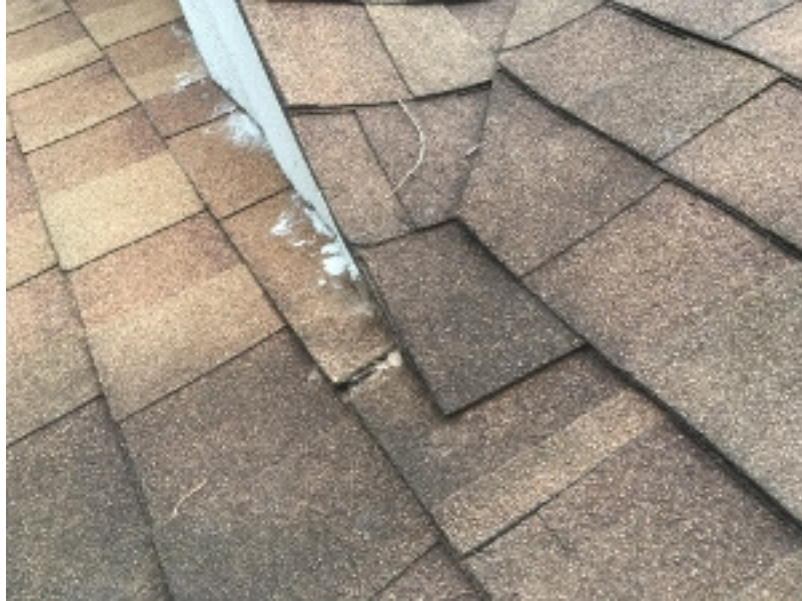
- THE VALLEY FLASHING – Does not terminate on top of the singles at the rear of the right gable above the garage.

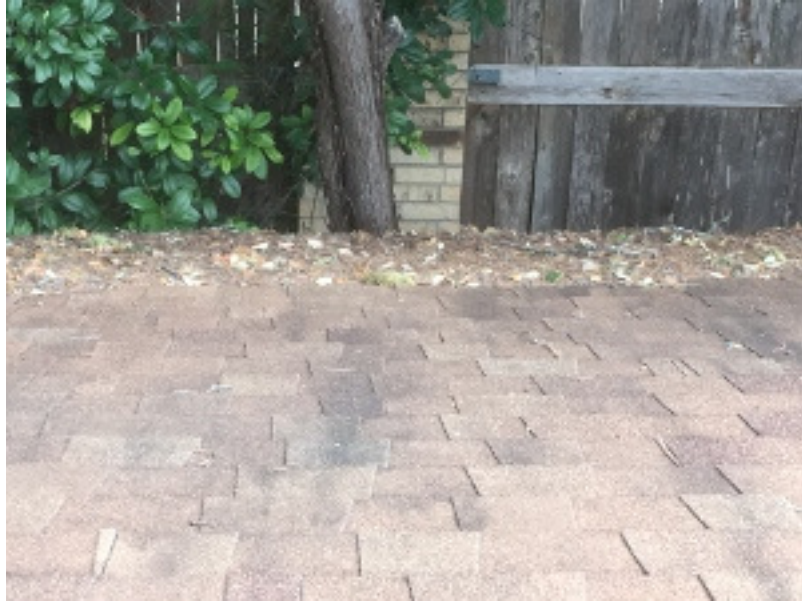
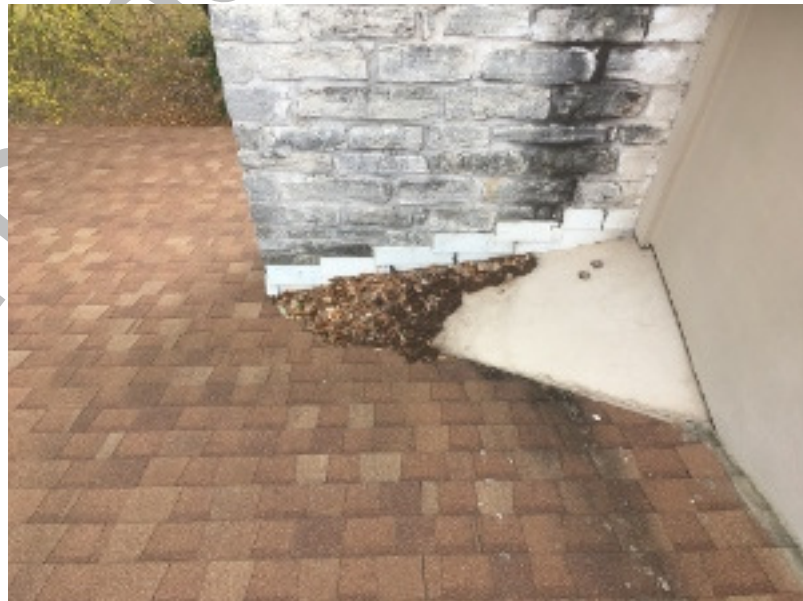
- THE ROOF – Remove the debris from the roof at various locations.

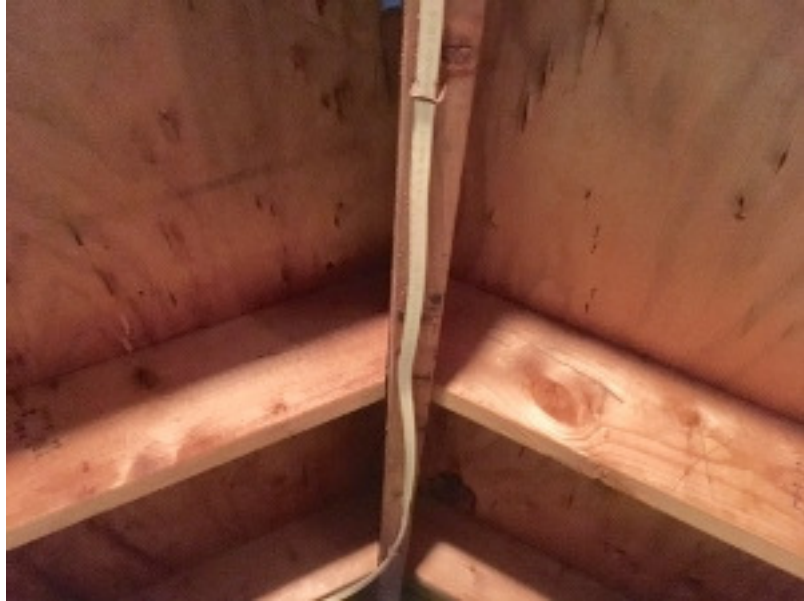
- THE ROOF DECKING HAS NOT BEEN CUT 2 TO 3 INCHES AT THE RIDGE – To create an opening that allows the ridge vents to work.

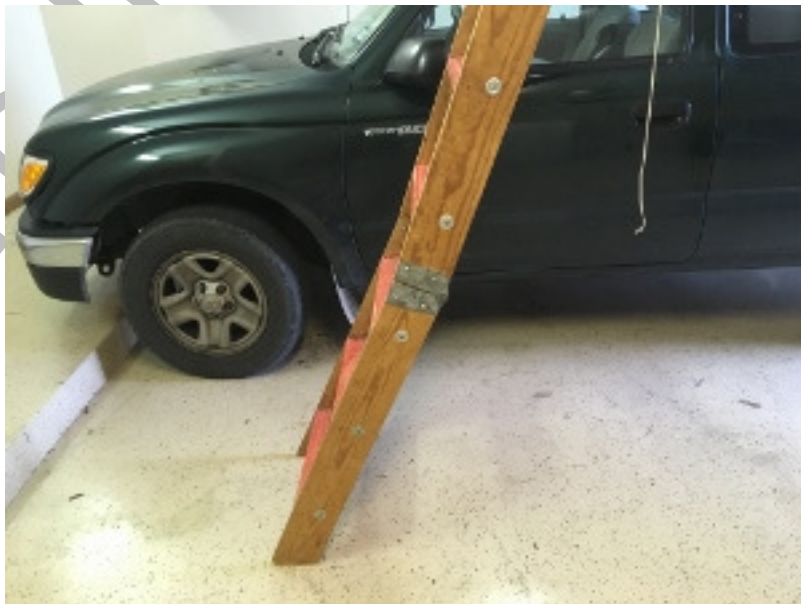
- THE ATTIC DOOR (PULL DOWN STAIRS) – Cut the legs of the stairs so that the stairs are straight & the hinges are properly engaged. The garage attic door is not a fire rated door.

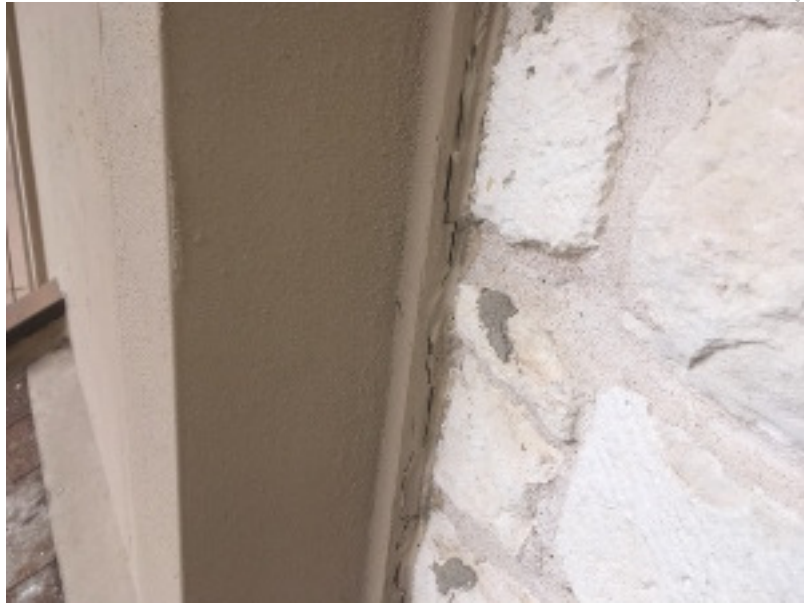
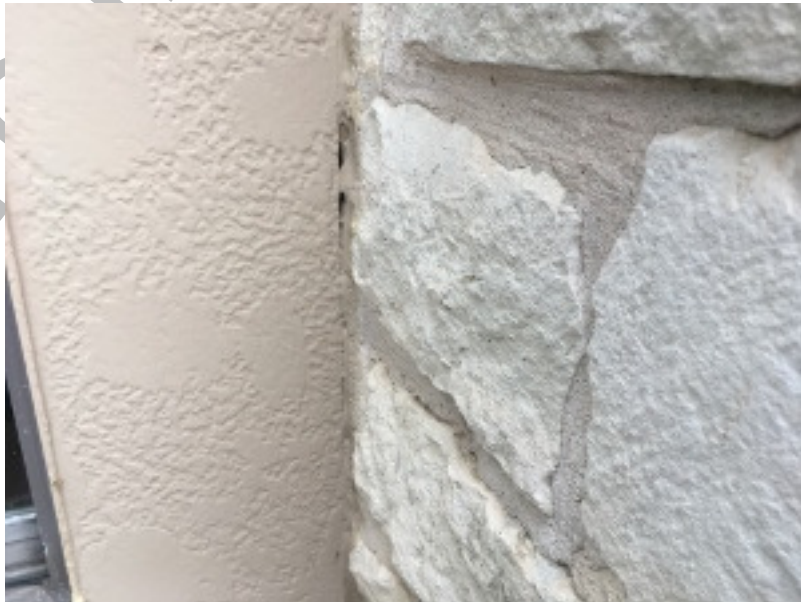
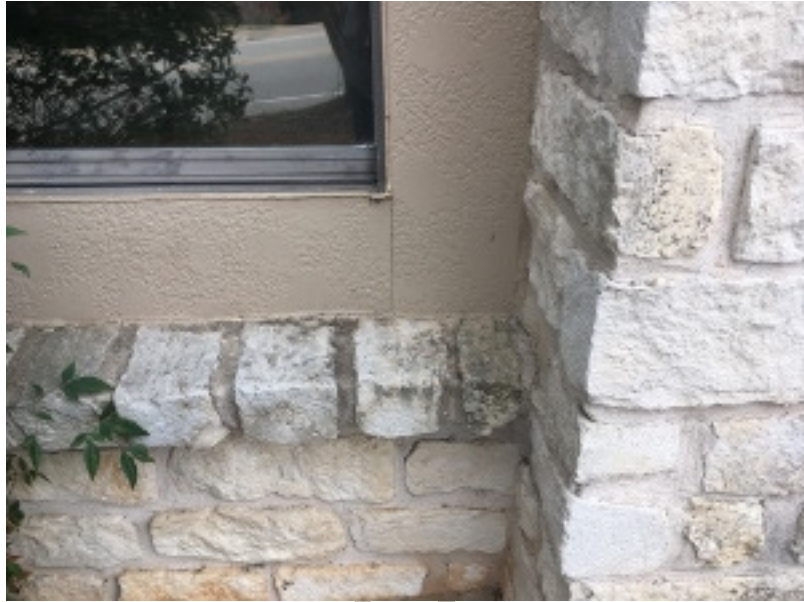
- RESEAL THE EXTERIOR – At the rock moldings, the windows, the trim & the siding connections at various locations (to prevent water penetration). Seal all the wall penetrations. The maintenance of the sealants will be an ongoing process.

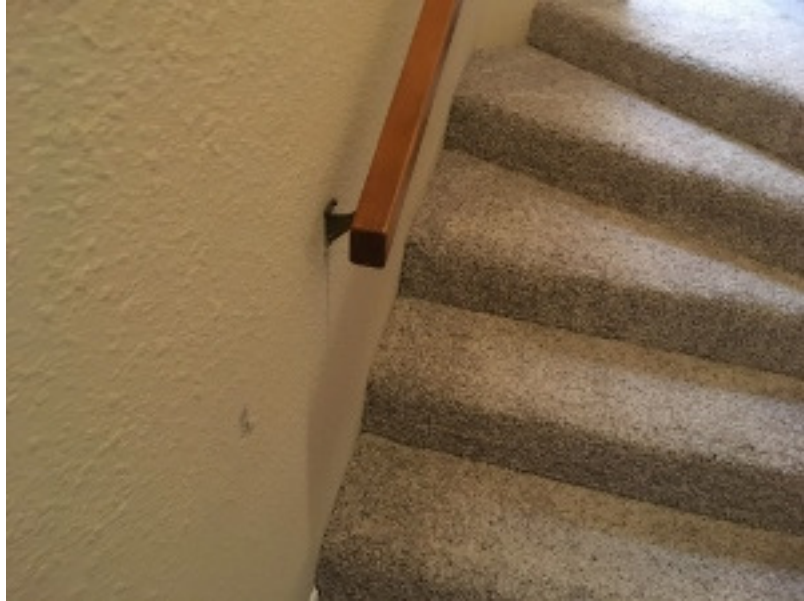
- THE HANDRAILS – The handrails do not turn back to the wall at the top / bottom ends at various locations.

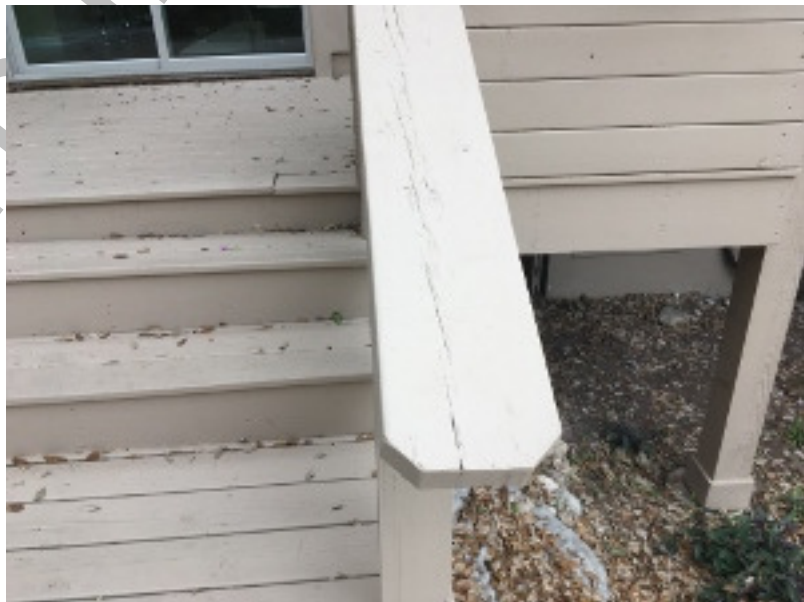
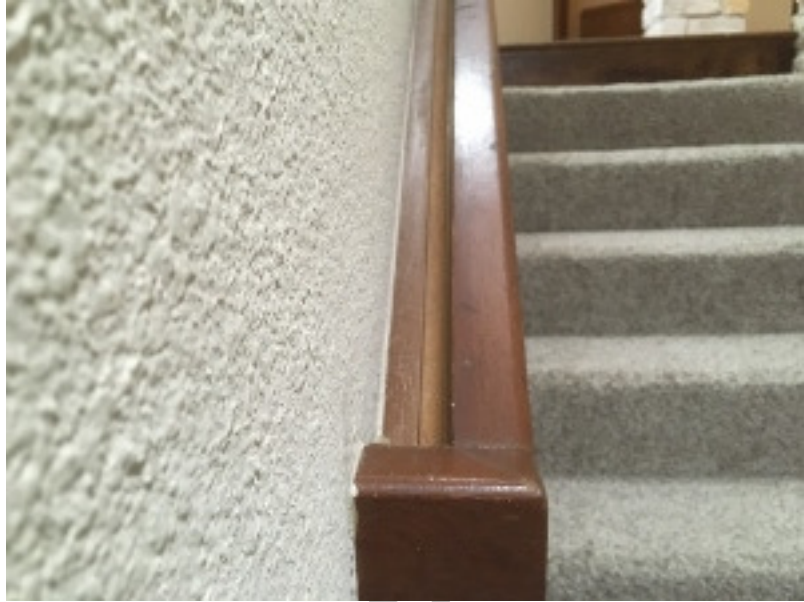
- A PROPER HANDRAIL IS NOT PRESENT – At the rear porch & the bottom flight of stairs. The handrail grip size shall be a minimum of 1 ¼ inches to a maximum of 2 5/8 inches.

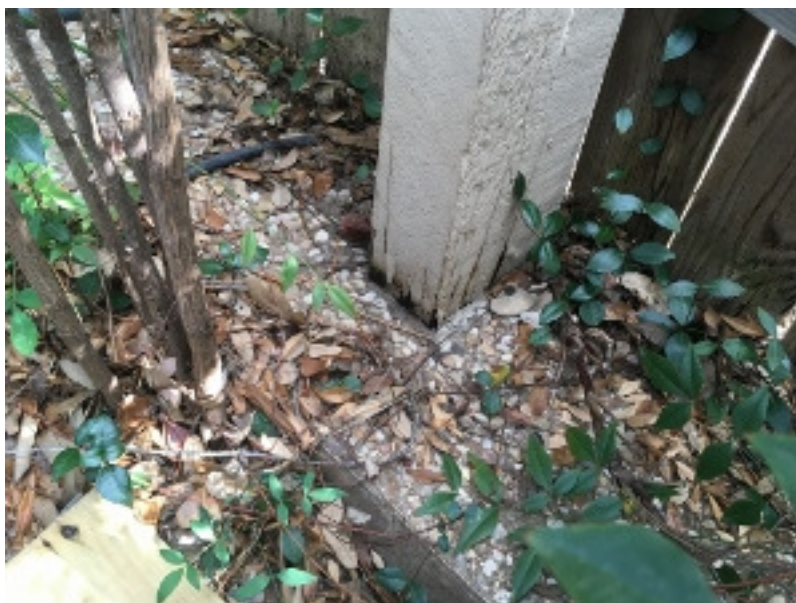
- THE REAR DECK POSTS - Have wood to soil / concrete contact, add post holders at the left. The bottoms of the posts are damaged / decayed at various locations. The posts should be repaired / replaced.

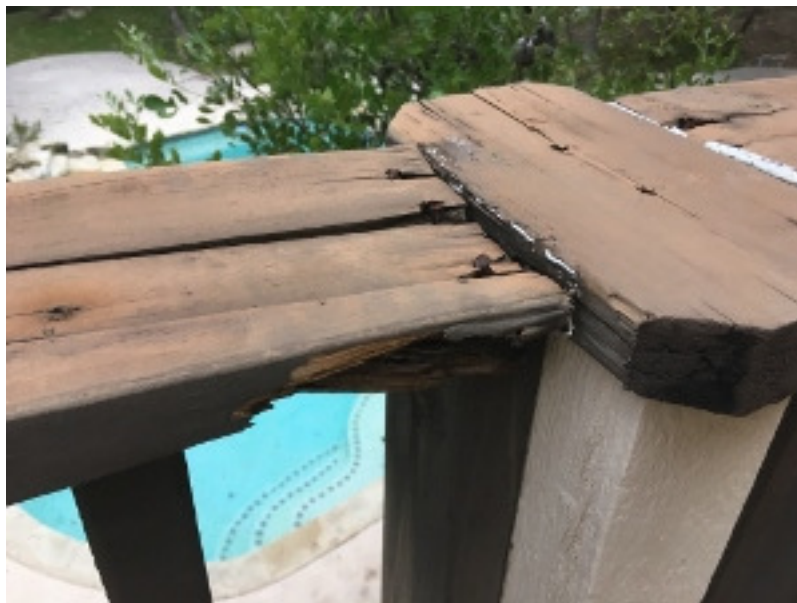
- THERE IS DAMAGE / DECAY – At various locations at the floor boards, railings & pickets, especially at the master deck.

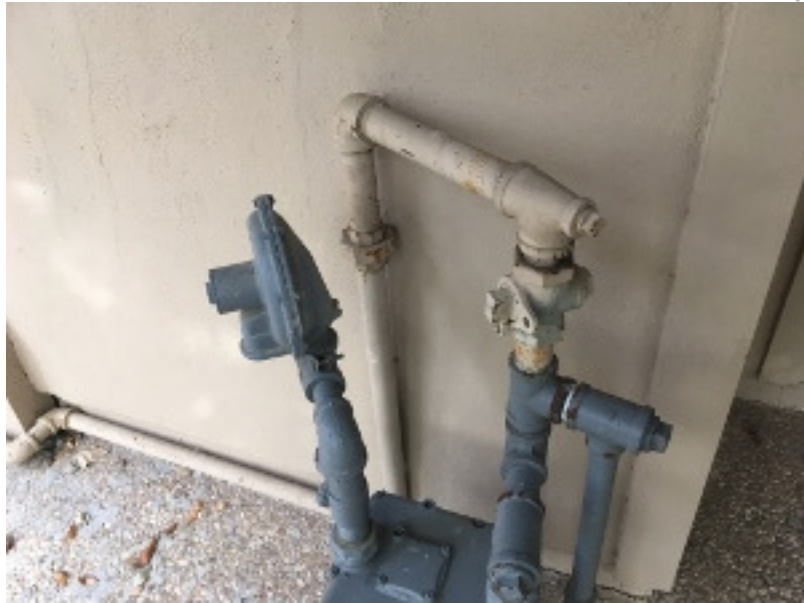
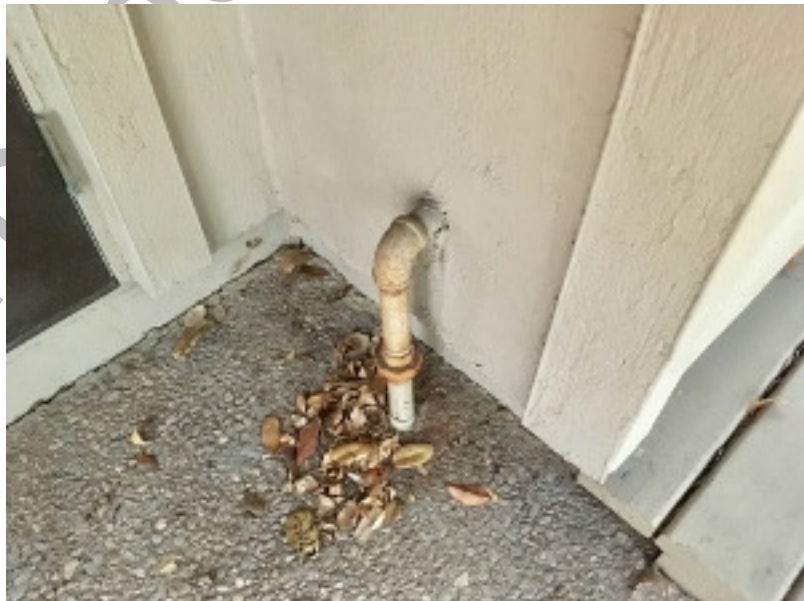
- The swimming pool equipment is not bonded.
- The metal water line does not appear to be bonded. Have a licensed electrician evaluate the water line.
- The gas line is not bonded.

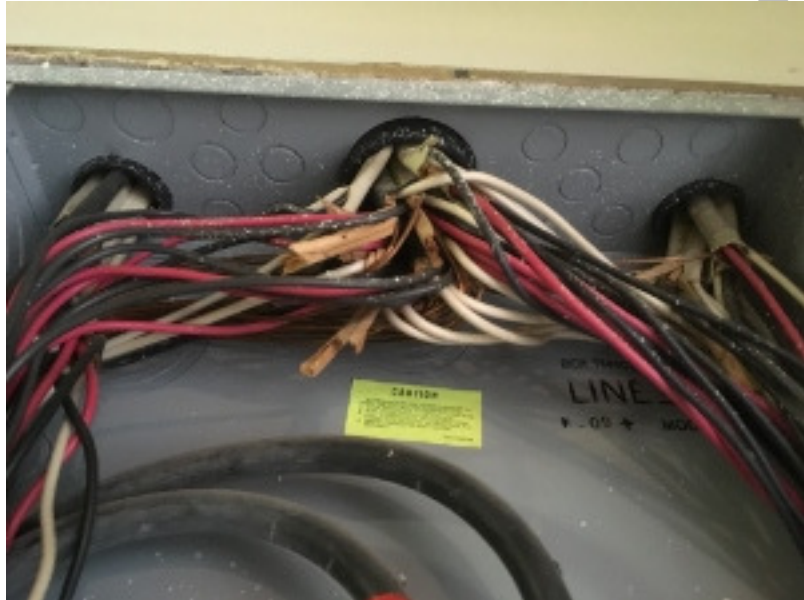
- THE MAIN BREAKER BOX - All the wires pass through 3 large holes in the top of the box, which creates a heat issue. The holes are not closed / sealed to prevent the potential spread of fire from the box into the wall. The wires are not connected to the box.

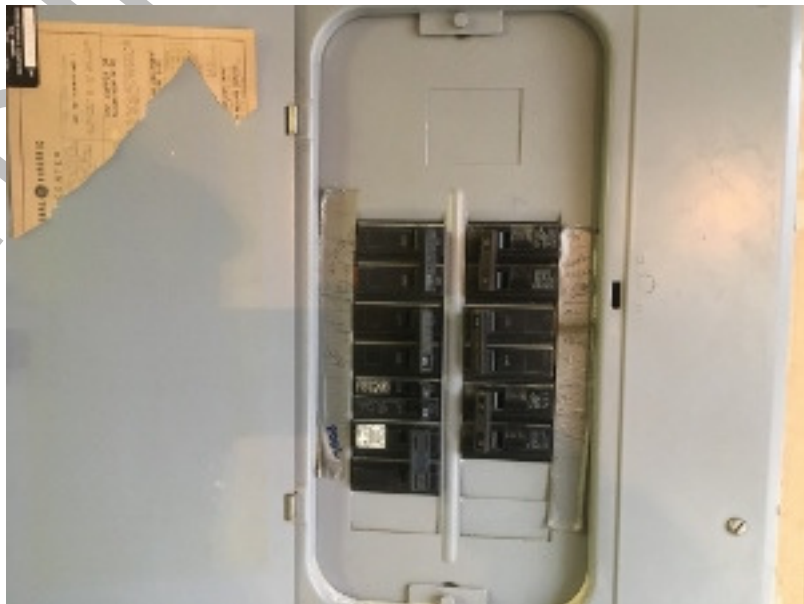
- THE LEFT MAIN BREAKER BOX - Does not have a main disconnect, required when more than 6 breakers are present (if it is to be considered a 2<sup>nd</sup> main box).
- If it is to be considered a secondary box, it is not bonded.

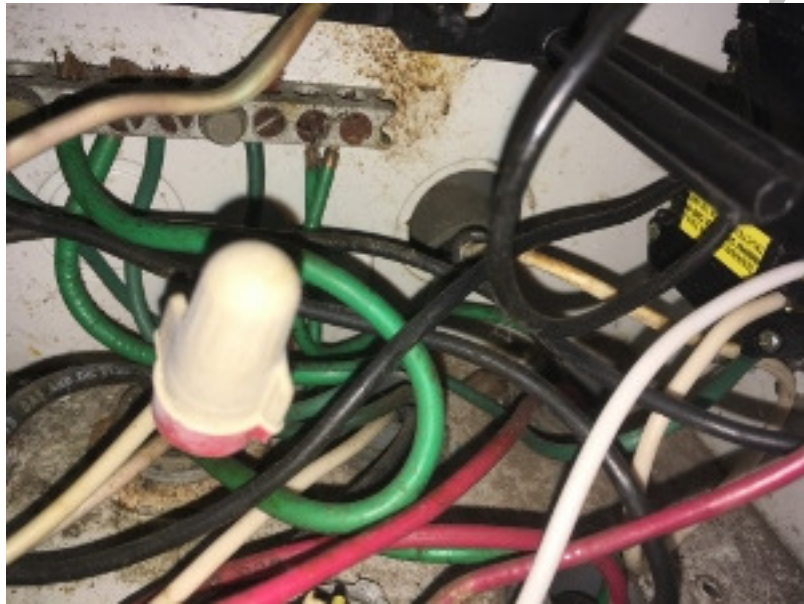
- THE POOL SECONDARY BREAKER BOX – The box is not bonded.

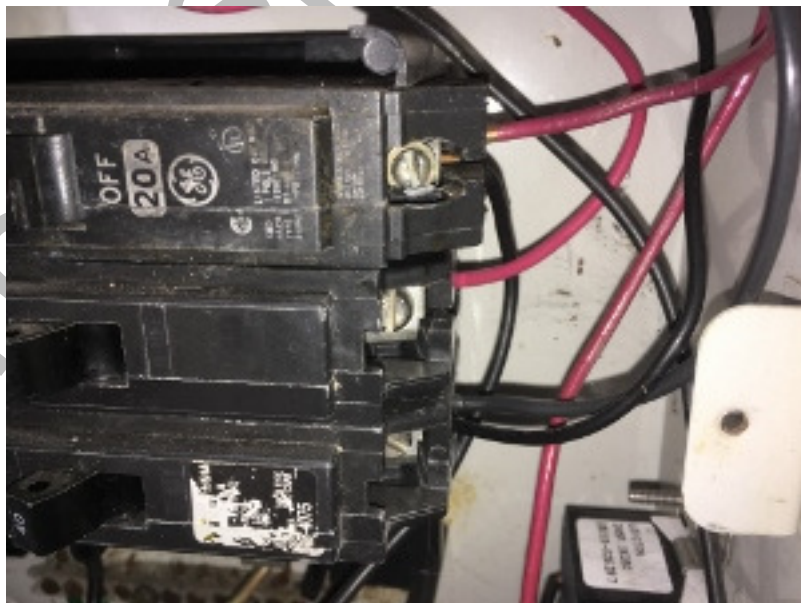
- The box has 2 double lugged breakers, add 2 breakers & separate the 2 wires on the double lugged breakers to 1 wire per breaker.

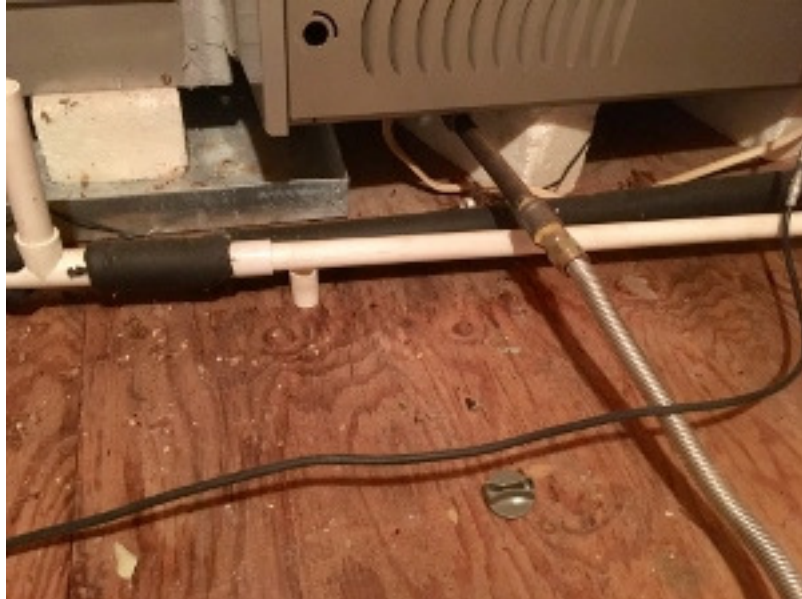
- THE GAS LINE – Is missing a drip leg / sediment trap above the garage.

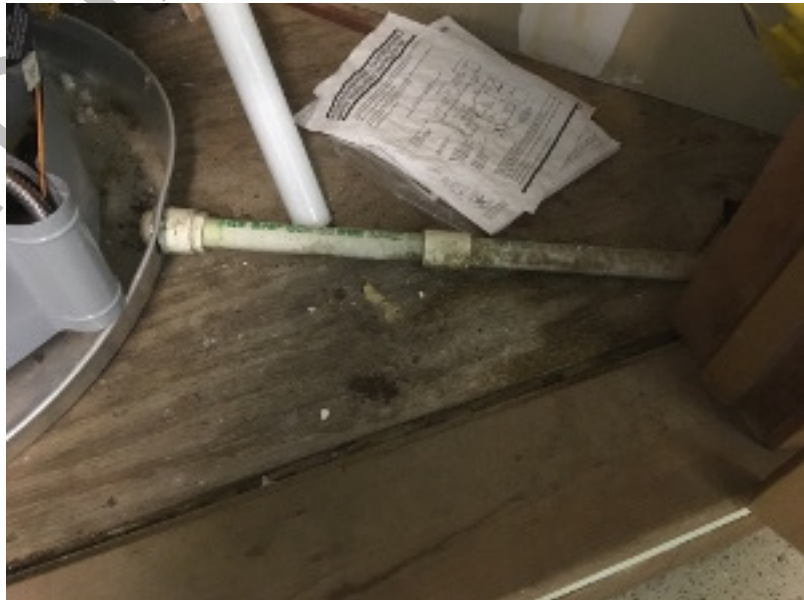
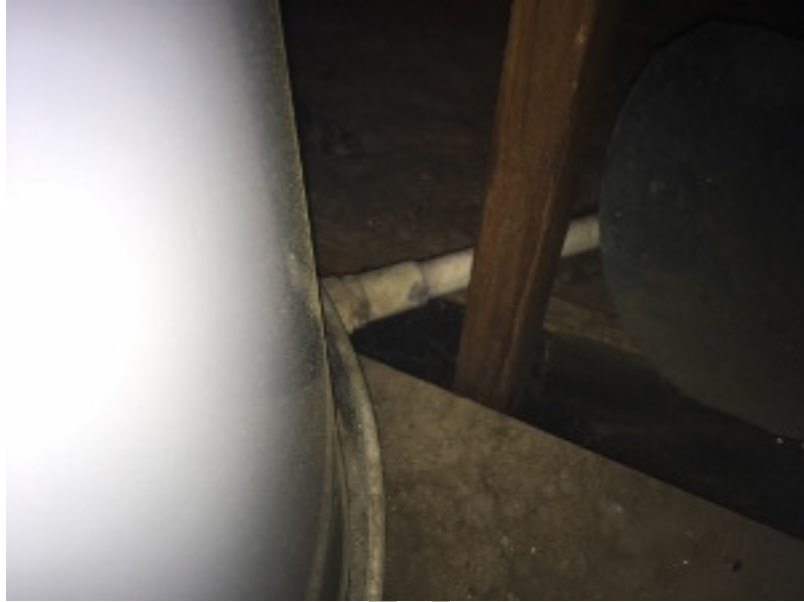
- EACH OVER FLOW PAN – Did not locate the termination of the line to the exterior. The drain lines are required to be CPVC pipe rather than PVC pipe (required as of the 2012 code). The use of PVC pipe is a common construction practice in the Central Texas area.
